# **Finding of the unexpected tsunami due to the strike-slip fault at central Sulawesi, Indonesia on 28 September 2018, from the preliminary field survey at Palu**

Abdul Muhari<sup>1</sup>, Fumihiko Imamura<sup>2</sup>, Taro Arikawa<sup>3</sup>, and Bagus Afriyanto<sup>1</sup>

Date; 15 October 2018

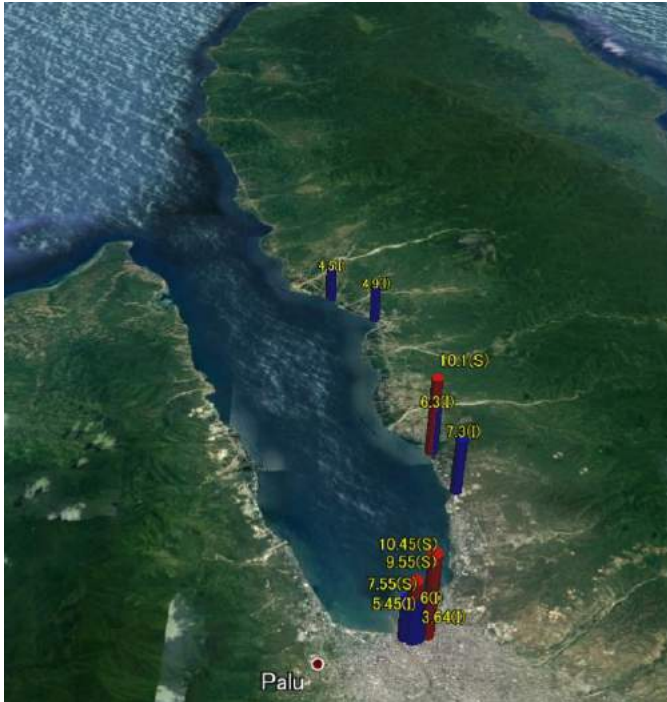
Figure1. The result of field survey data showing the tsunami heights of splash wave (red color) and flow depth (blue color) measured in Palu bay overlaid in Google earth, without tidal correction (Muhari et al, 2018 JDR submitted).

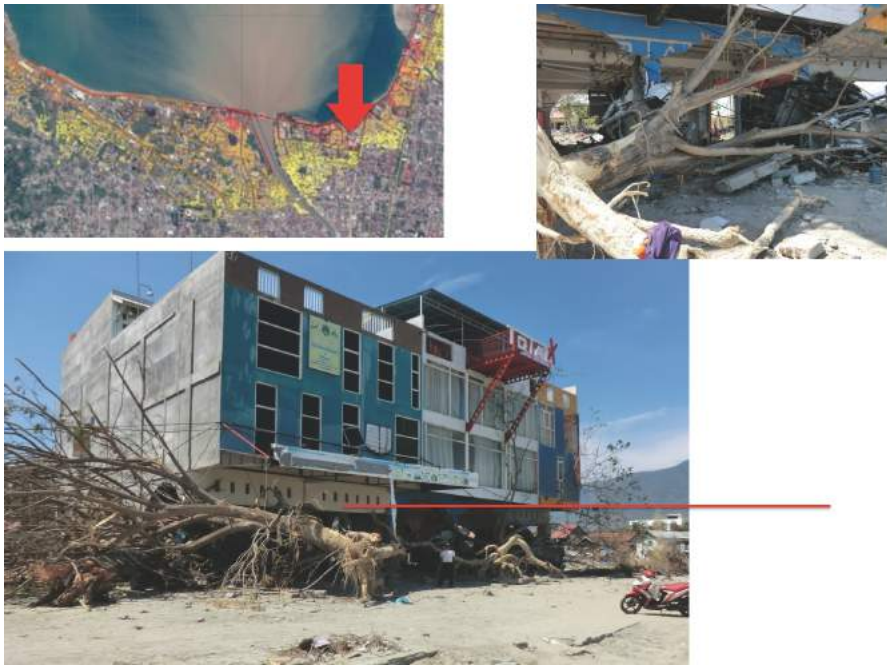
Photo 1 Damaged house where the debris such as trees, cars and motorcycles affected the 1<sup>st</sup> floor

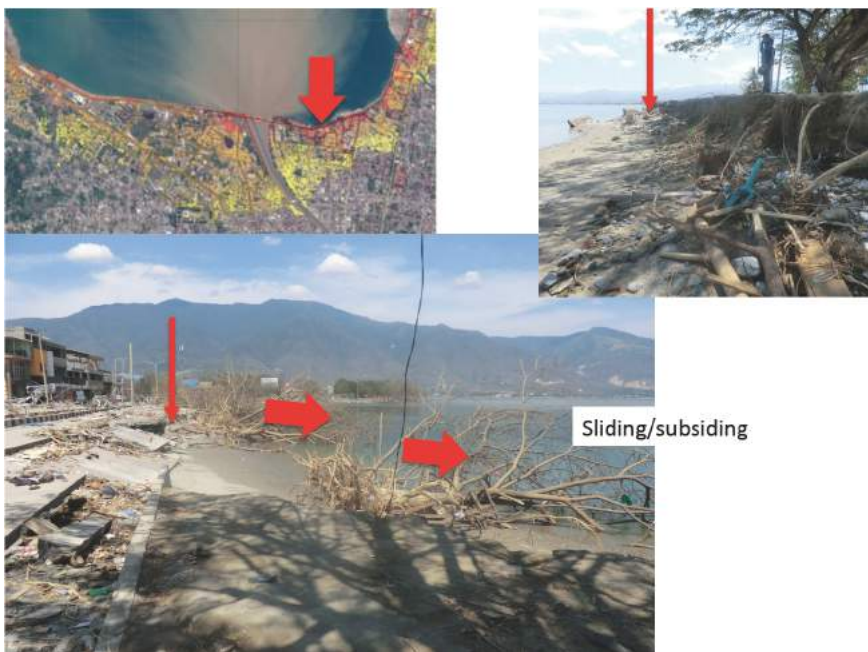
Photo 2 damaged coastal area where the subsidence in large area and backward trees to the sea are observed.

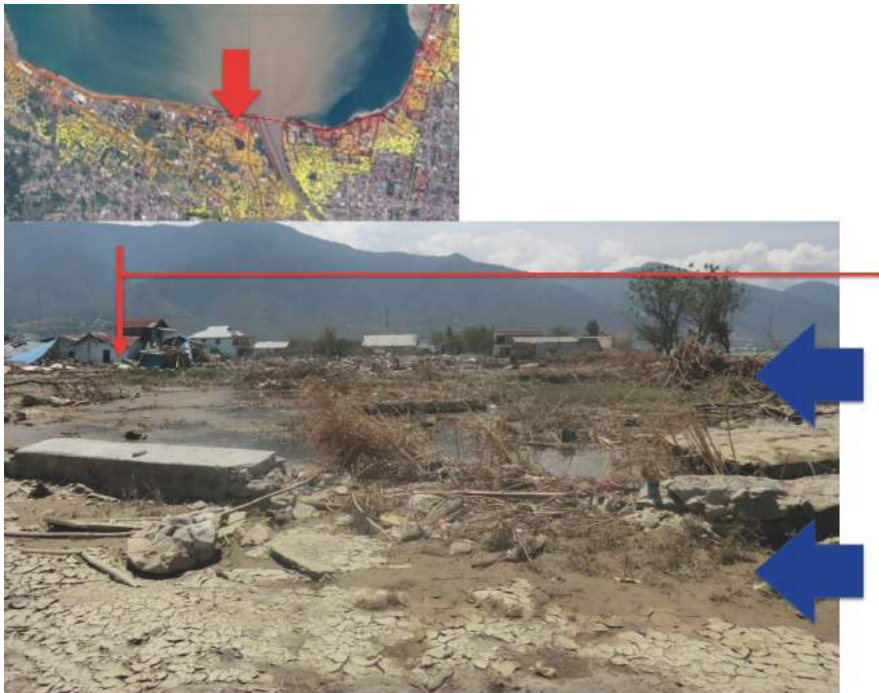
Photo 3 Damaged area due to the strong current of tsunami, causing scouring or erosion on the land where no houses remains.

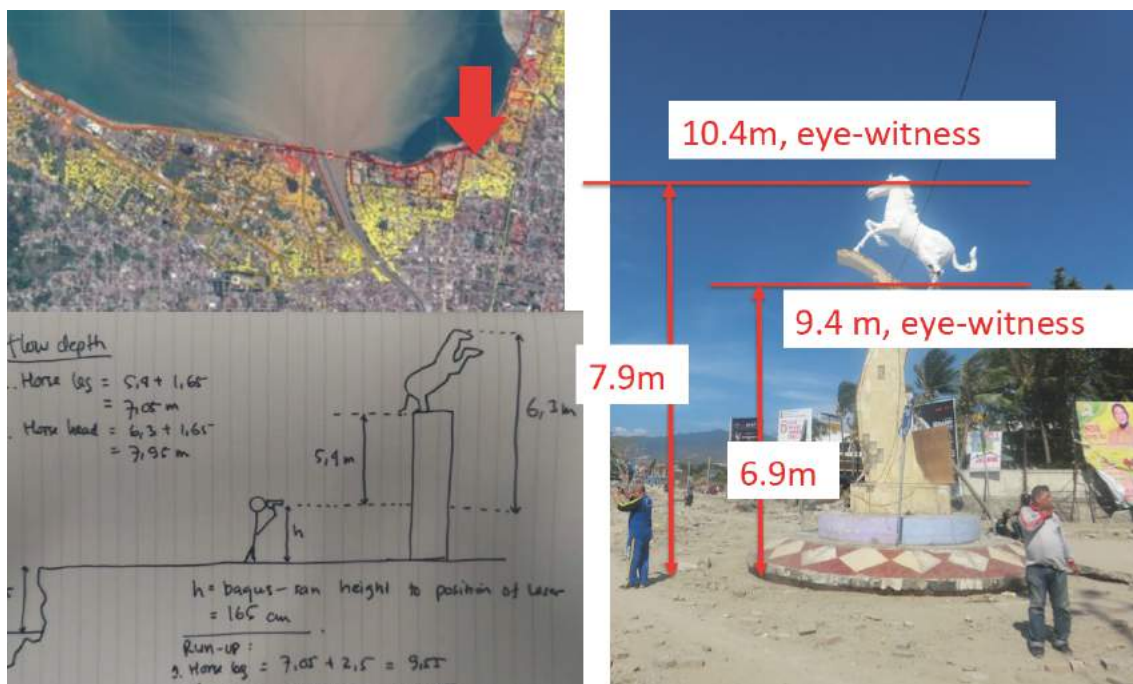
Photo 4 A depth of splash wave up to about 8 m from the ground level and about 10 m from the sea level as stated by the eyewitnesses, without tidal correction.

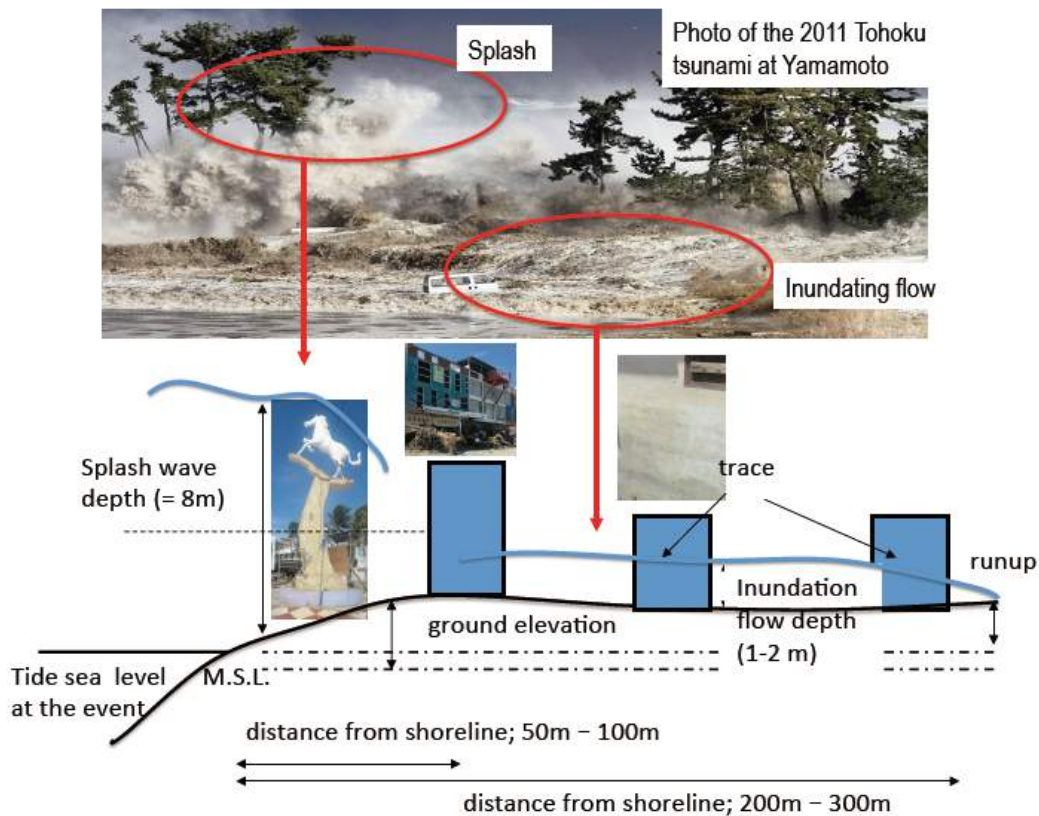
Figure 2 Cross section of the tsunami and topography at the Palu with splash wave/inundation flow depth (Muhari et al, 2018 JDR submitted)

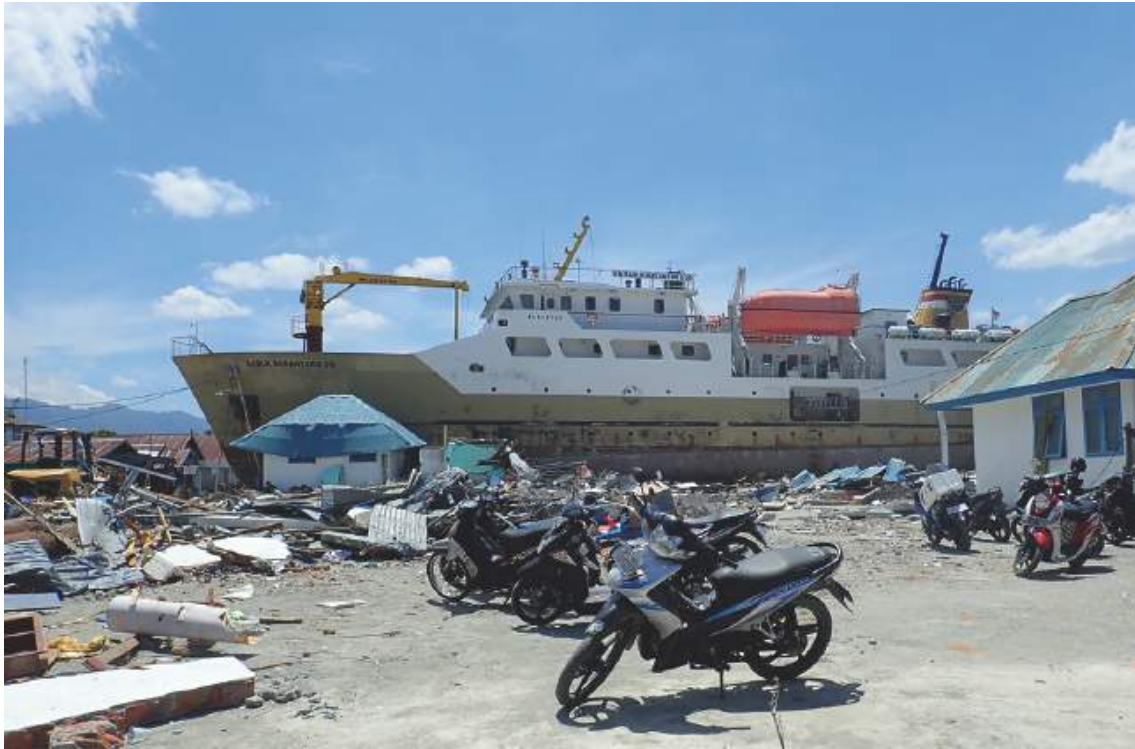
Along the east side of the bay, at Pantoloan the large vessel with about 50 m long was landed shown in Photo 5. Here, then inundation depth was around 1.9 m and ground height was 2.3m, so that inundation height was about 4.2 m. But the inundation stopped 180m from the coast. That means the length of this tsunami seems to be short. About tsunami behavior, the residence said that tsunami arrived in a few minutes after the earthquake motion.

Photo 5 The large vessel with about 50m long was landed at Pantoloan

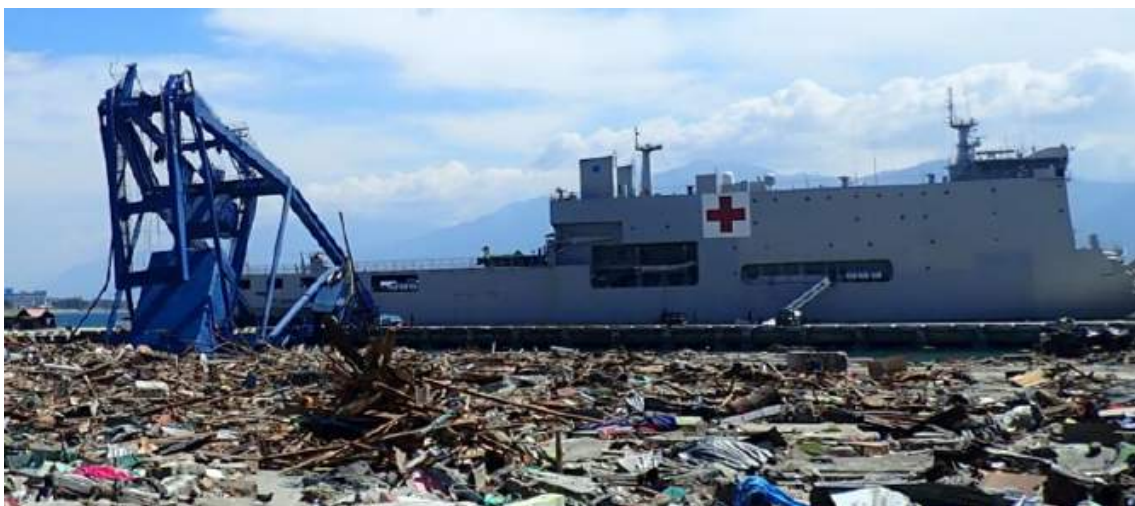
The port in Pantoloan, there were also many containers and small ships. The inundation height was 4.9m. The gantry crane was fallen because the foundation part had disappeared as shown in Photo 6. And the residence suggests that tsunami was coming from west north side.

Photo 6 The gantry crane was inclined and almost fallen at Pantoloan

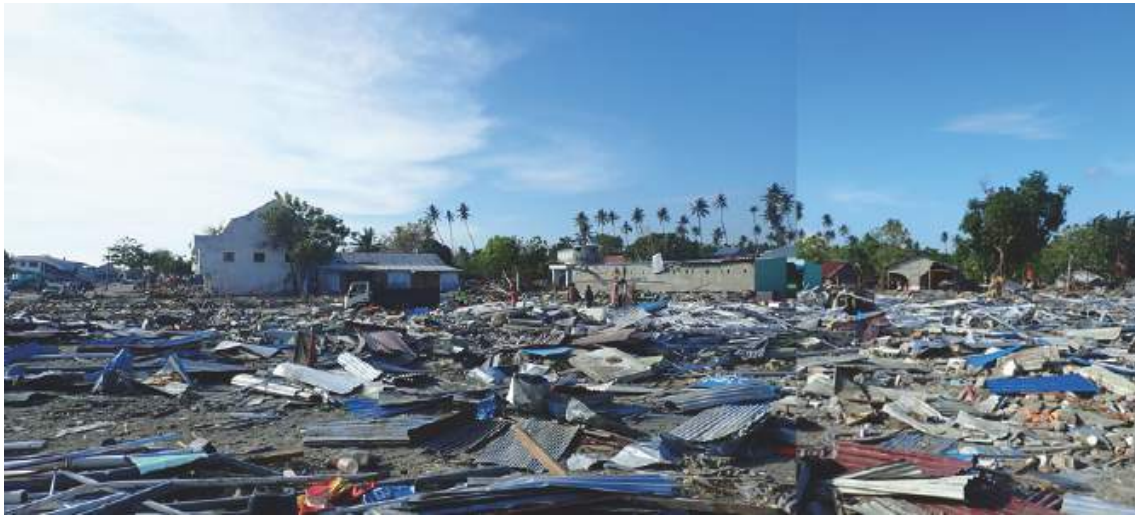
At Mamboro, there was more serious damage as shown in Photo 7. The inundation depth was around 4.5m and the ground height was around 2.0m. And the maximum splash height was 10.1m above the sea level. Photo 8 shows the house located nearby sea, which had some evidence of the splash wave. It indicated that the inundation flow speed seems to be relative high like bore.

Photo 7 The destruction status at Mamboro

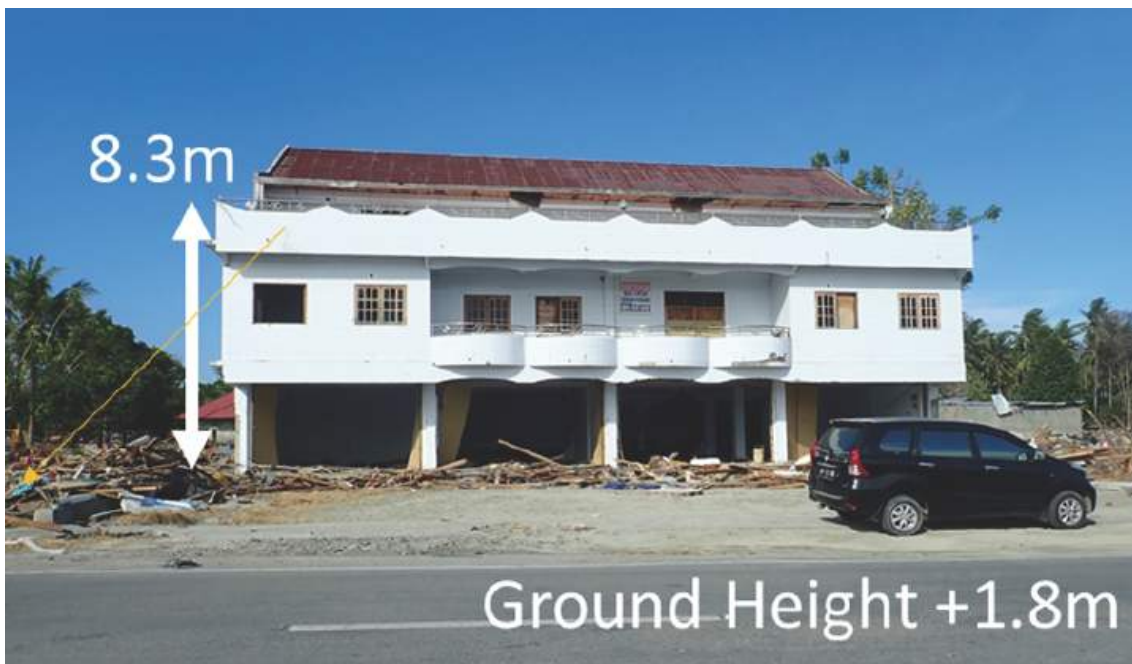
Photo 8 The house located nearby sea, which had some evidence of the splash wave, without tidal correction
