2023年ガズィアンテプ地震 による建物被害

東北大学 災害科学国際研究所
榎田竜太, 柴山明寛, 五十子幸樹

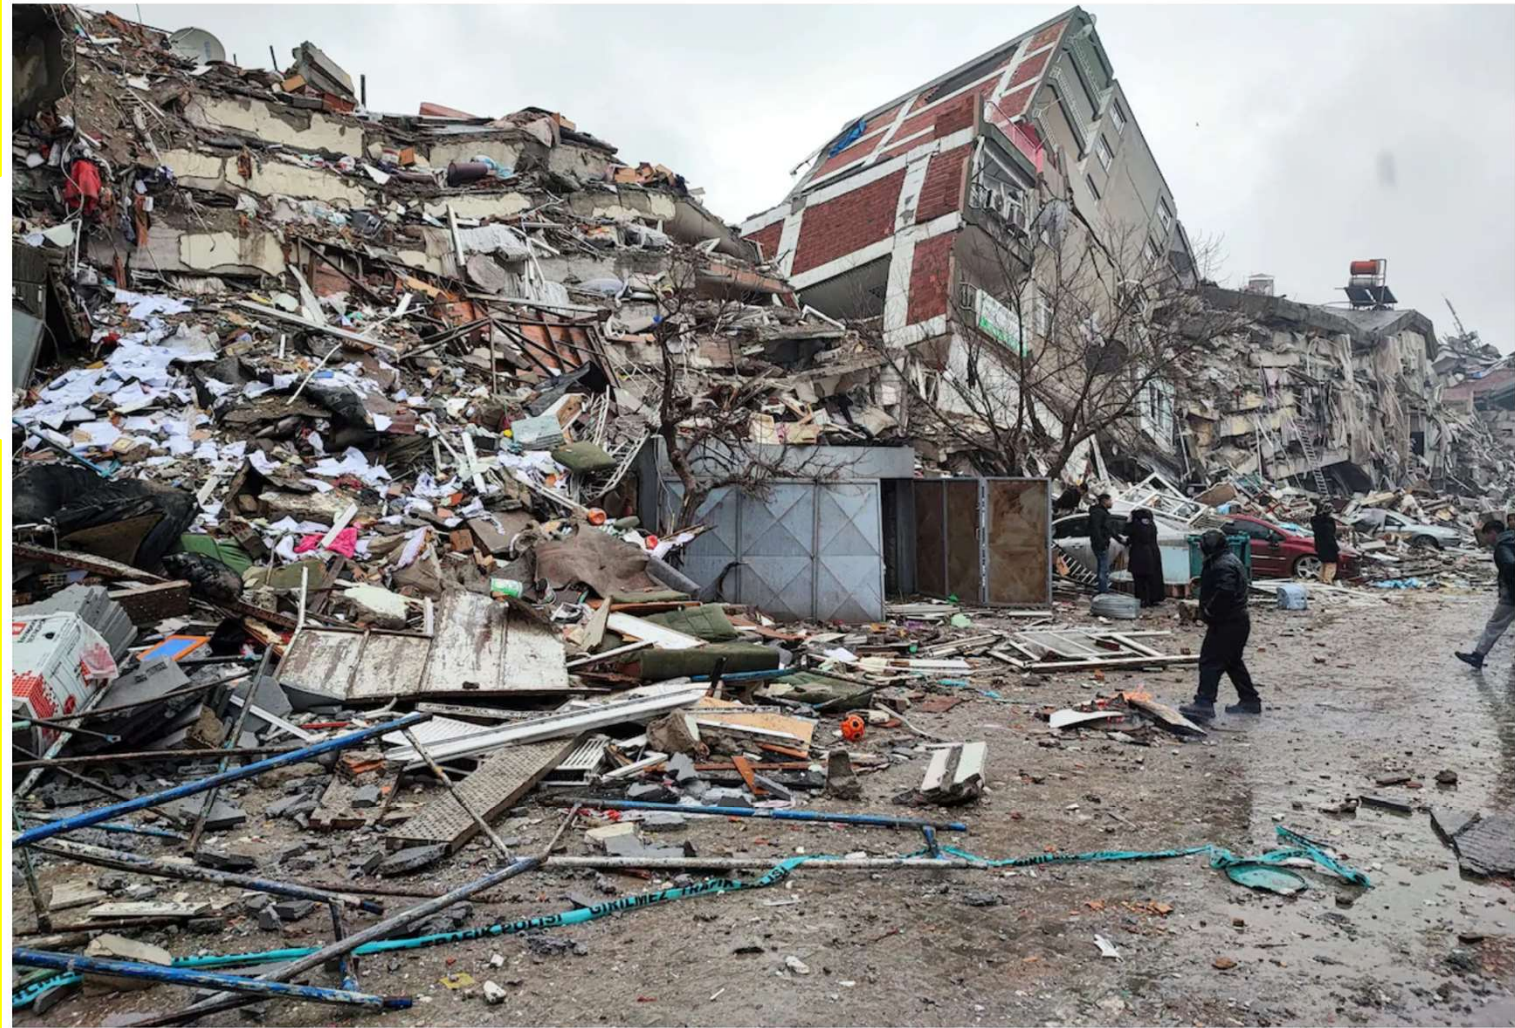
2. Kahramanmaras (カフラマンマラシュ, トルコ, 45 km)

Collapsed buildings in Kahramanmaras. (Ihlas News Agency (iha)/via REUTERS)

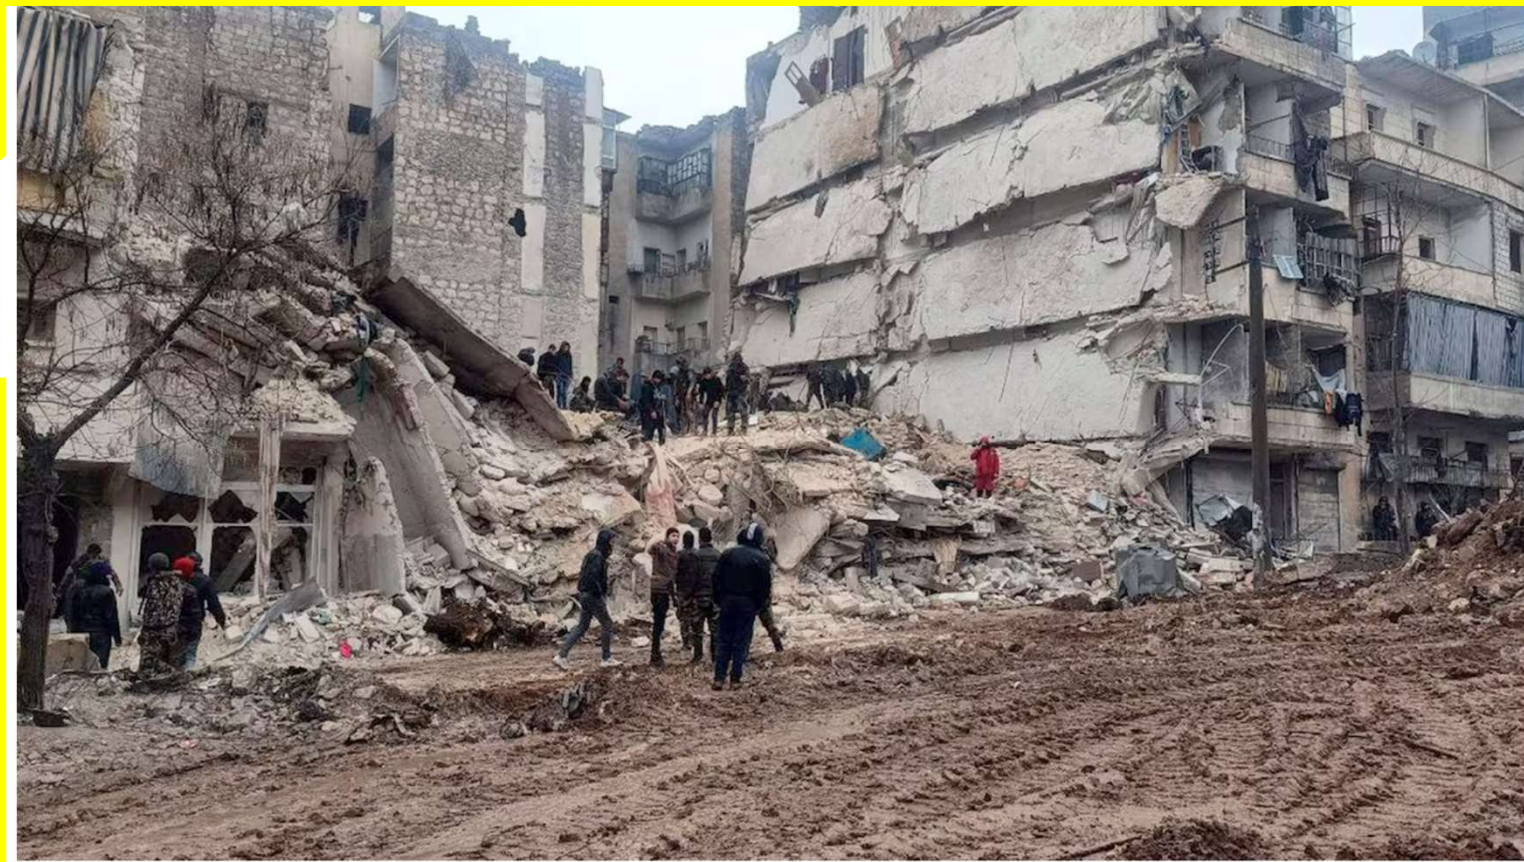
7. Aleppo (アレッポ, シリア, 100 km)

Collapsed buildings in the city of Aleppo. (SANA/Reuters)

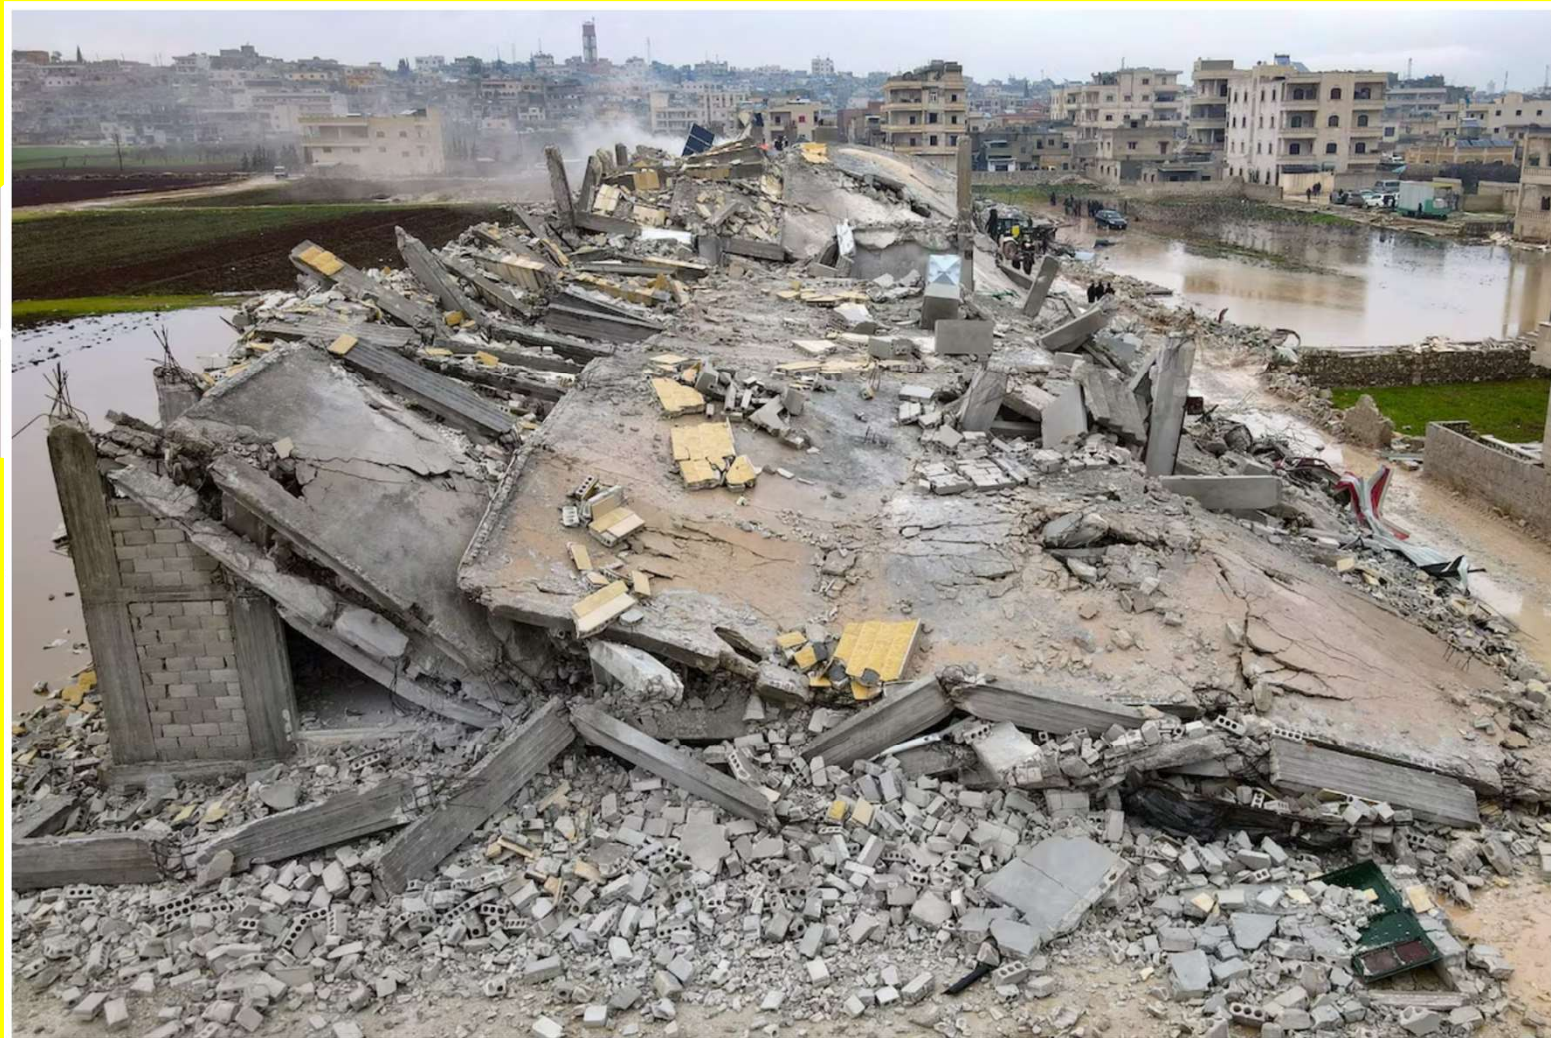
8. Sarmada (サルマダ, シリア, 110 km)

Flattened buildings in Sarmada, in Syria's northwestern Idlib province. (Muhammad Haj Kadour/AFP/Getty Images)

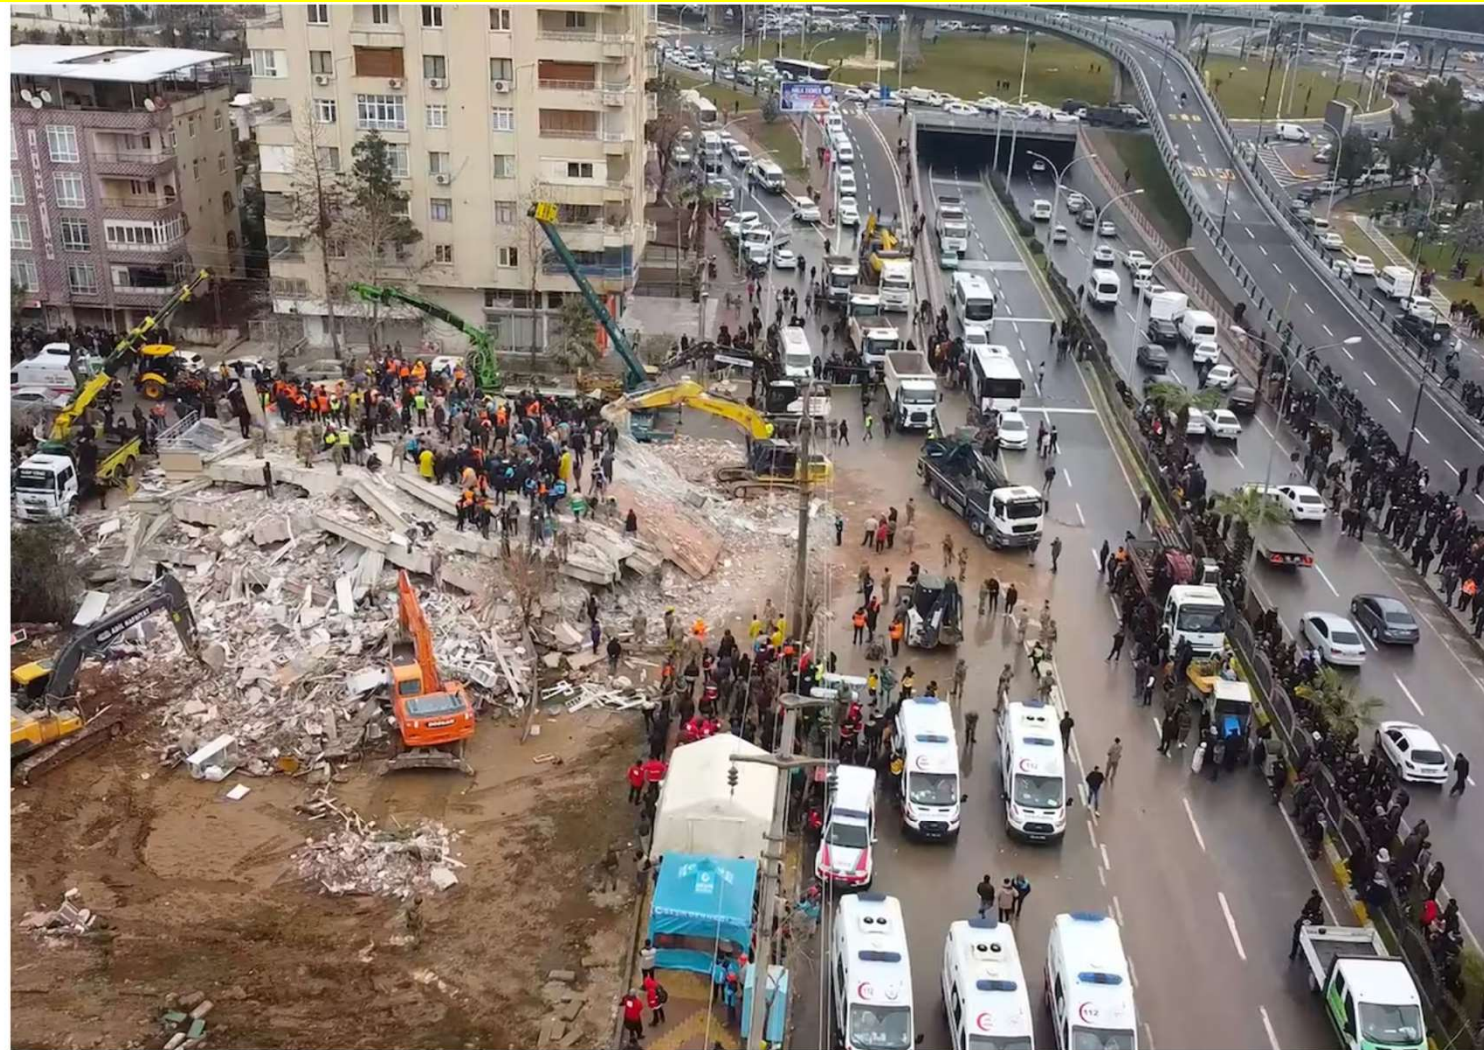
3. Sanliurfa (シヤルウルファ, トルコ, 155 km)

A building was reduced to rubble in Sanliurfa on Monday. (AFP/Getty Images)

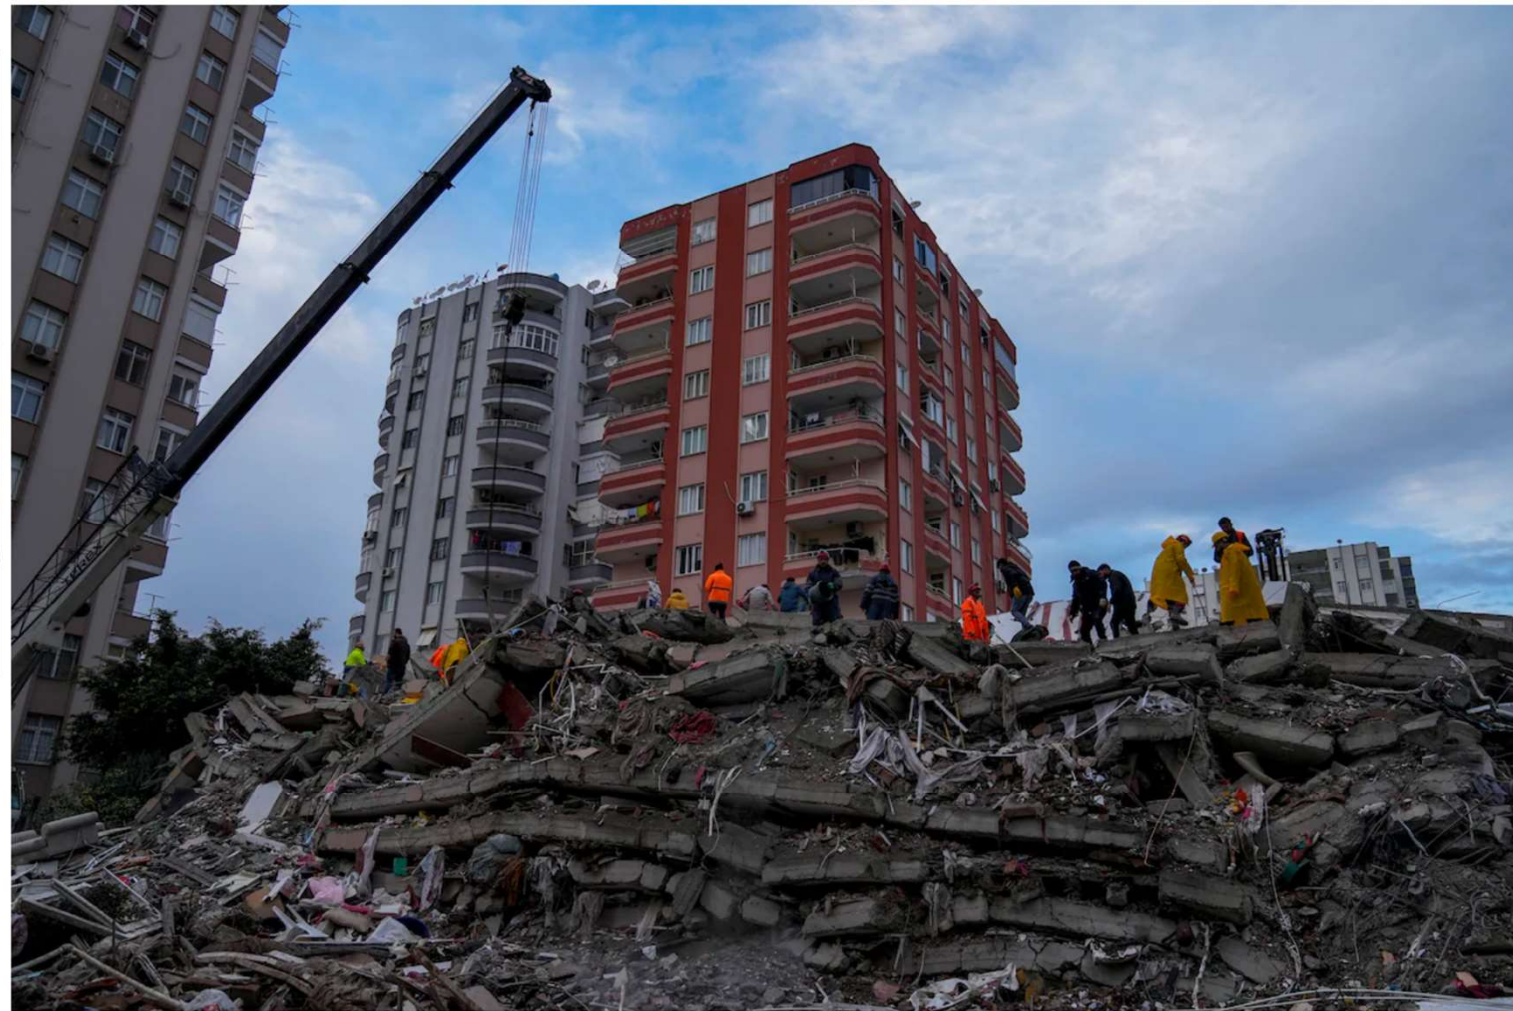
4. Adana (アダナ, トルコ, 155 km)

Emergency workers search for survivors in a destroyed building in Adana. (Khalil Hamra/AP)

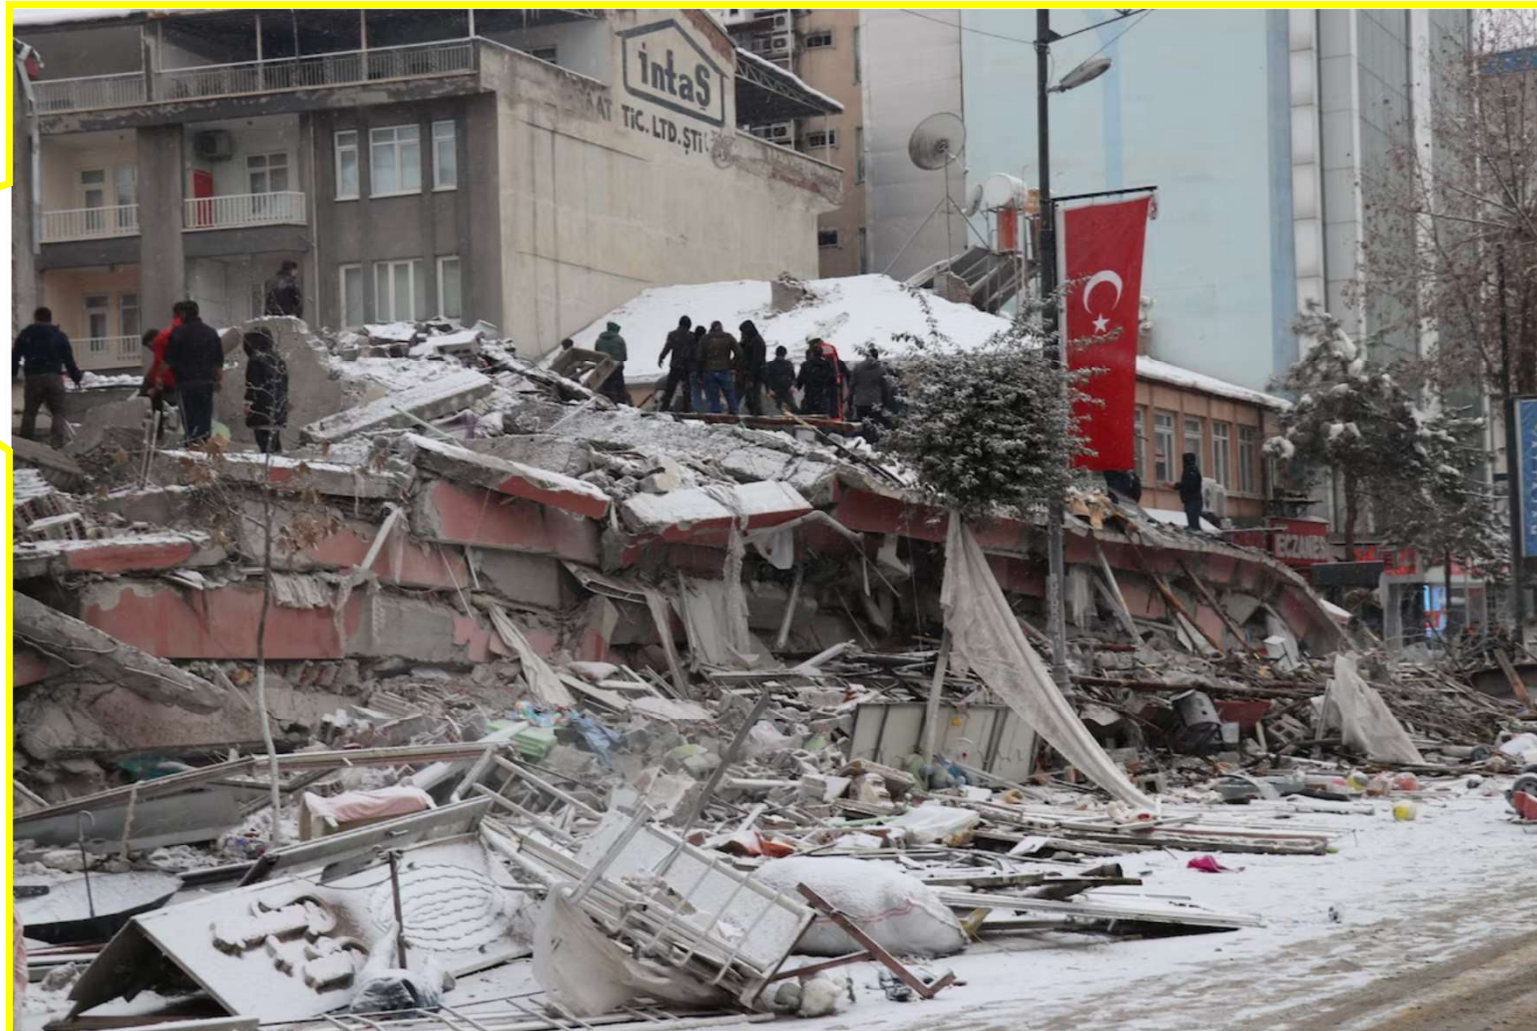
1. Malatya (マラティヤ, シリア, 170 km)

Rescuers work Monday on a collapsed building in Malatya. (Ihlas News Agency (iha)/Reuters)

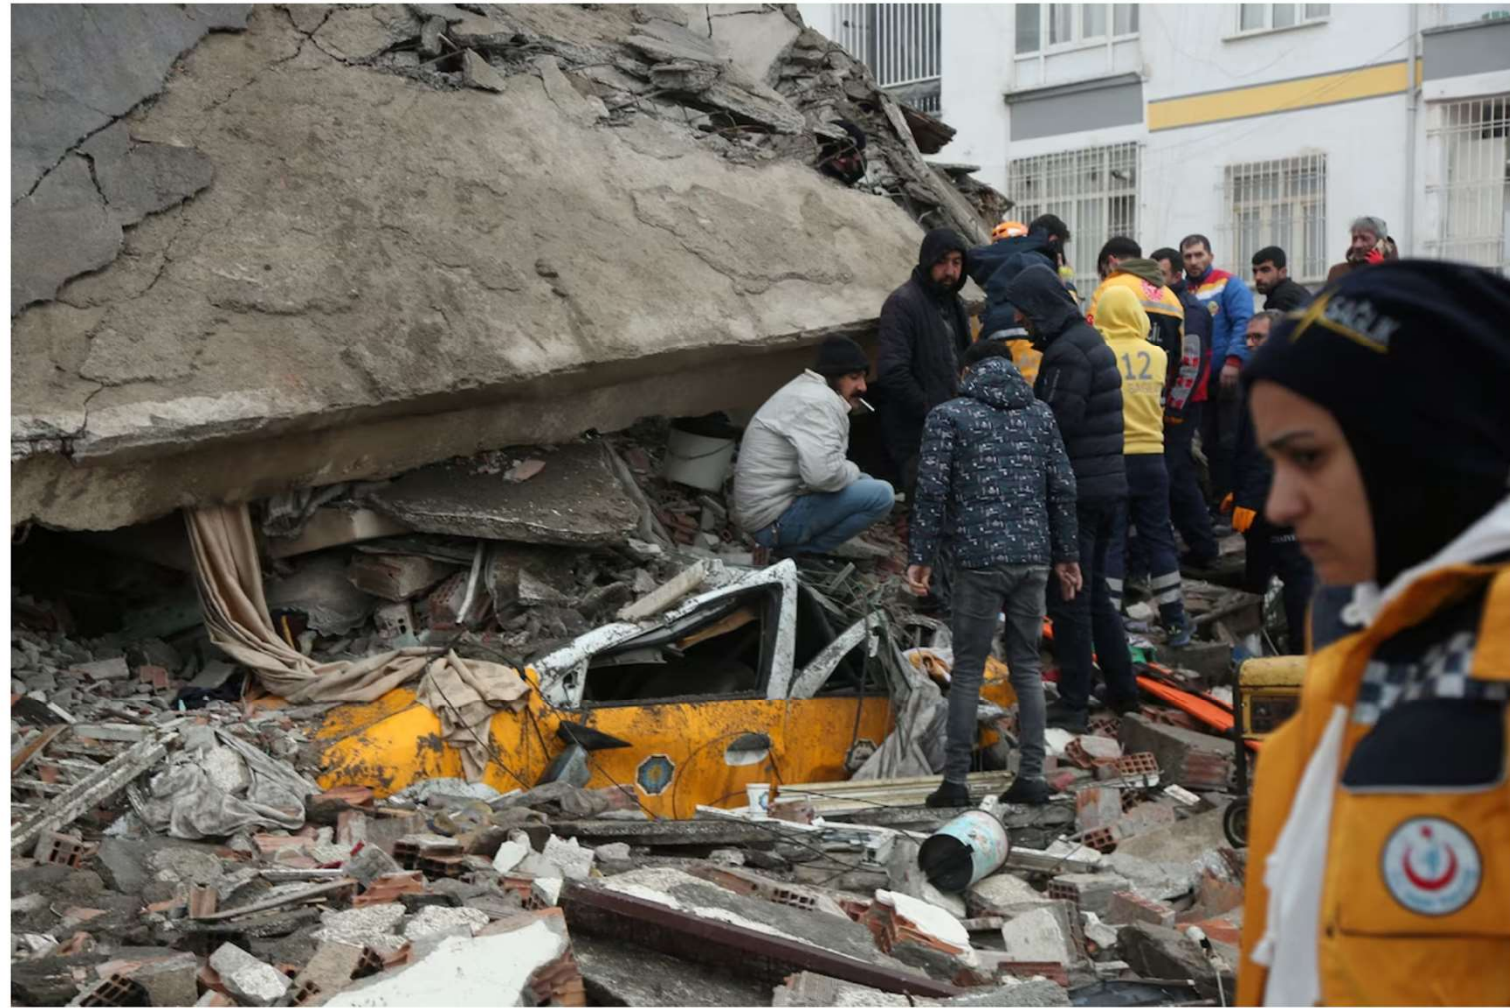
5. Diyarbakir (ディヤルバクル, トルコ, 290 km)

A car is crushed beneath the rubble in Diyarbakir. (Sertac Kayar/Reuters)
