Overview of Myanmar Tectonic Setting and Seismicity

Overview of Sagaing Fault and Sagaing Earthquake (2025)

Overview of Inle Lake (UNESCO World Heritage)

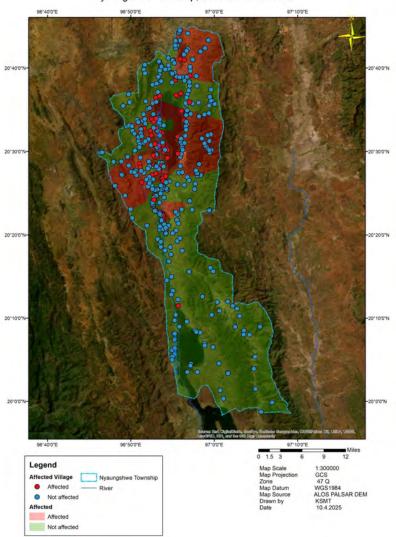
Building Damage Map of Village Point and Village Tract Area around Inle Lake Nyaungshwe Township, Southern Shan State

According tentative survey, 50 people killed by building collapsed and 2297 buildings was damaged and 13347 affected people were accounted.

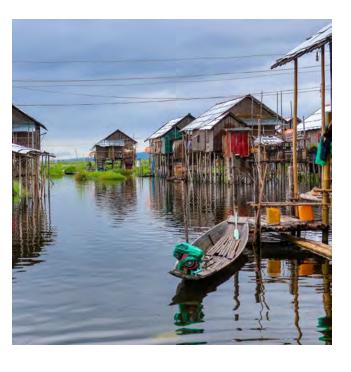
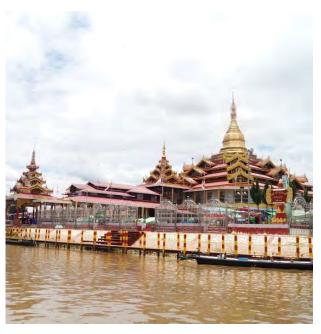
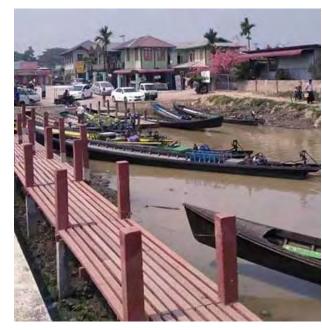
Building and Foundation Style

- Type 1: The unique and prominent building style in Inle Lake is constructed in the water. The timber pile is driven by human load up to safe bearing soil. It built up to three stories but most of them are two stories.
- Type 2: Some buildings applied shallow footing. The retaining wall is constructed, fill the backfill soil on the lake deposit, in the retaining wall and found the shallow footing on the fill soil.
- Type 3: The building constructed on the lake banks are found on natural soil, mostly with shallow footing.
- Most of the damaged buildings are type-1, a few are type 2 and there is
 no building damage which are constructed on lake banks.

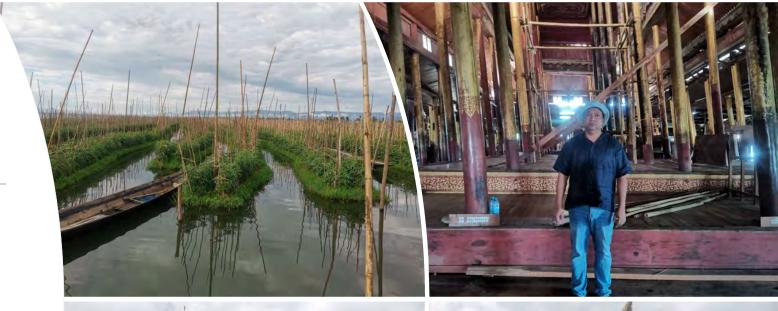
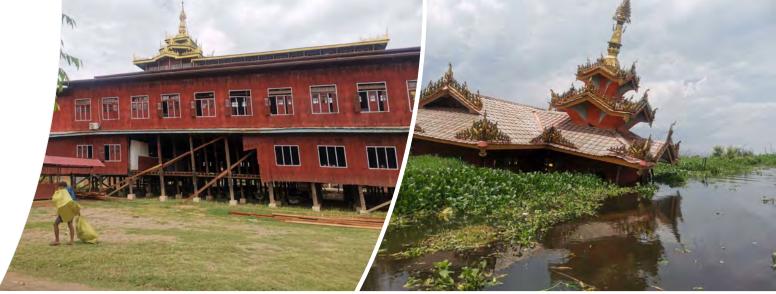
Damage of Ancient Temples and Floating Garden

- Buddhist Monasteries in Inle Lake and most of the Shan State are significant not only for religious matter but also serve as shelter for festivals, ceremonies, education center, justices, community center and guest houses.
- Floating gardens are highly productive vegetable farms made with lake weeds and measured by length (Taung – 18 inch)
