Survey of bridges washed out in MinamiAizu, Fukushima Prefecture. Sep 18, 2015. Jeremy D. Bricker and Kazuhisa Goto.

Shizugawa, Takahashi Bridge

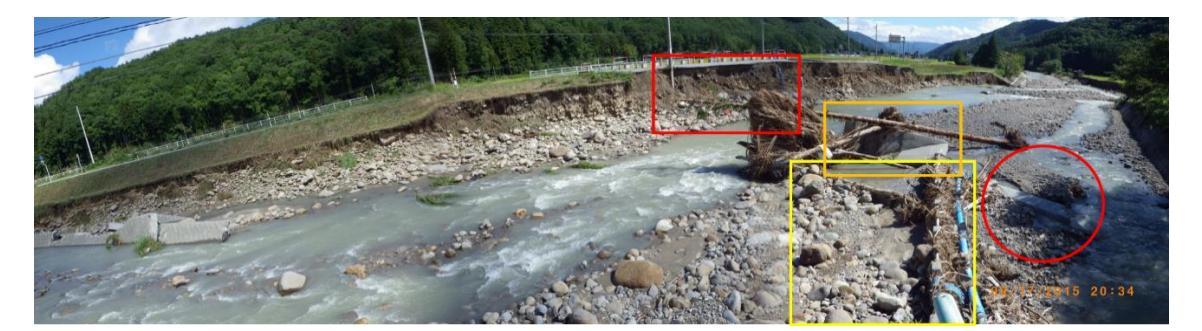
On Sep. 18, 2015, we investigated damage to bridges in Minami Aizu, Fukushima Prefecture. In the Shizukawa neighborhood of Minami Aizu, we investigated the failure of the Takahashi Bridge (Map 1). This was a concrete girder bridge with 3 deck sections, each 15 m long, standing atop 2 piers in the river and 2 abutments on either bank. As shown in Photo 1, the south deck, abutment, and pier survived. The bridge did not appear to have been overtopped by the flood. The north pier toppled sideways, likely due to scour at its base. The north abutment also toppled into the river likely due to scour. The north deck and middle decks both toppled into the river when the pier and abutment toppled. The middle deck can be seen partially buried in the riverbed, though the north deck had already been removed by construction crews. The north bank suffered severe erosion. Remains of the north embankment concrete armor wall can be seen in the photo.

Photo 1. Takahashi Bridge. Taken from south deck, looking northeast. Yellow square is partially buried middle deck. The toppled north deck had already been removed by construction crews. Red circle is toppled northern pier. Orange rectangle is toppled portion of northern abutment. Red rectangle is scoured northern approach.

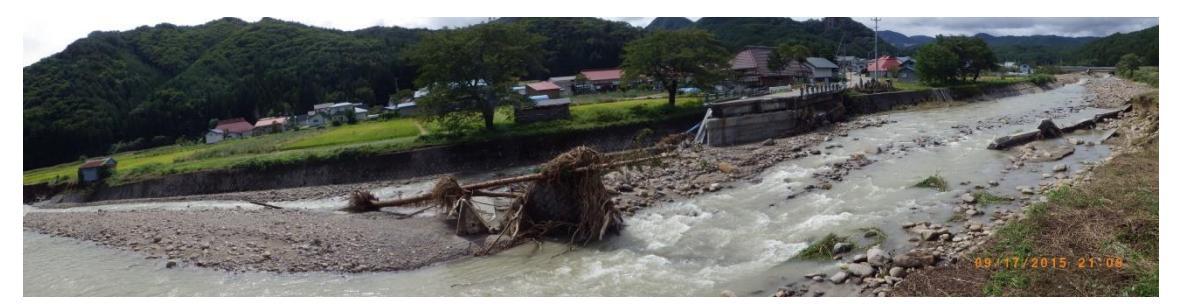
Photo 2. Takahashi Bridge. Taken from northern approach, looking southwest.

Photo 2 shows the surviving south deck, pier, and abutment. The south embankment and its armor wall are also intact. The large item in the middle of the photo is an overturned slab of concrete embankment armor from the north bank.

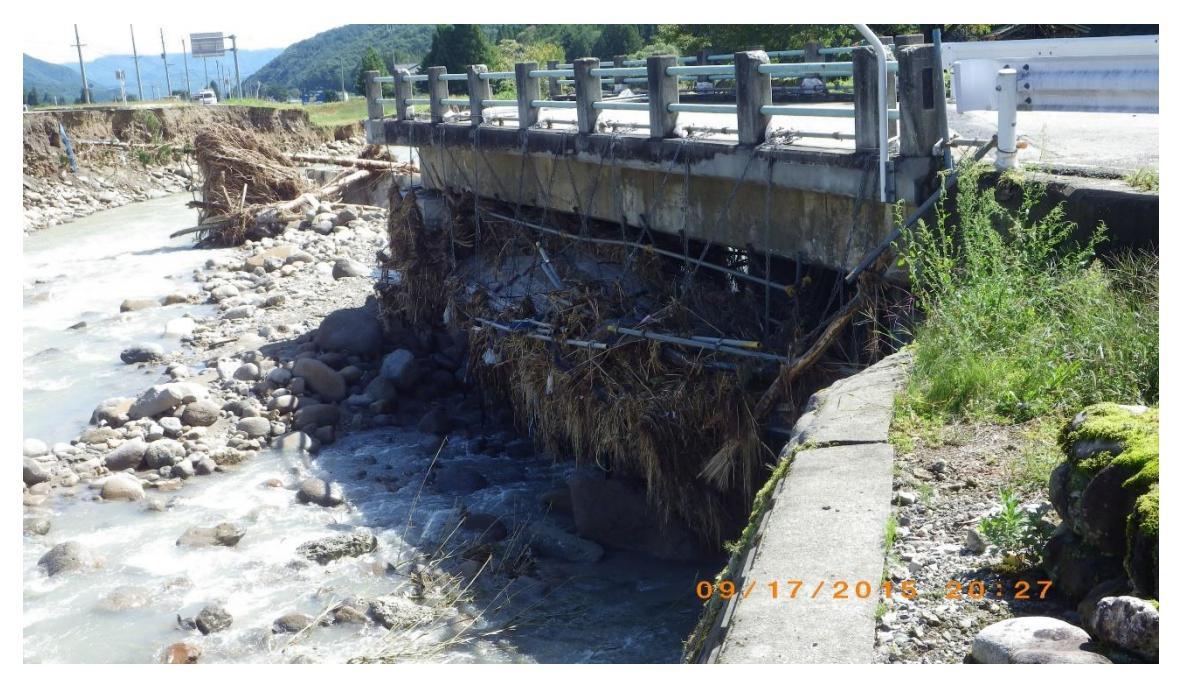
Photo 3. Takahashi Bridge. Taken from west of southern approach, looking northeast.

Photo 3 shows the surviving south deck. Construction scaffolding on the upstream side of the girder caused debris (mostly grasses) to accumulate. The resulting debris damming did not damage this deck, but it may have caused more flow to divert toward the middle and north sections of the bridge, increasing flow speed and thus scour potential there.

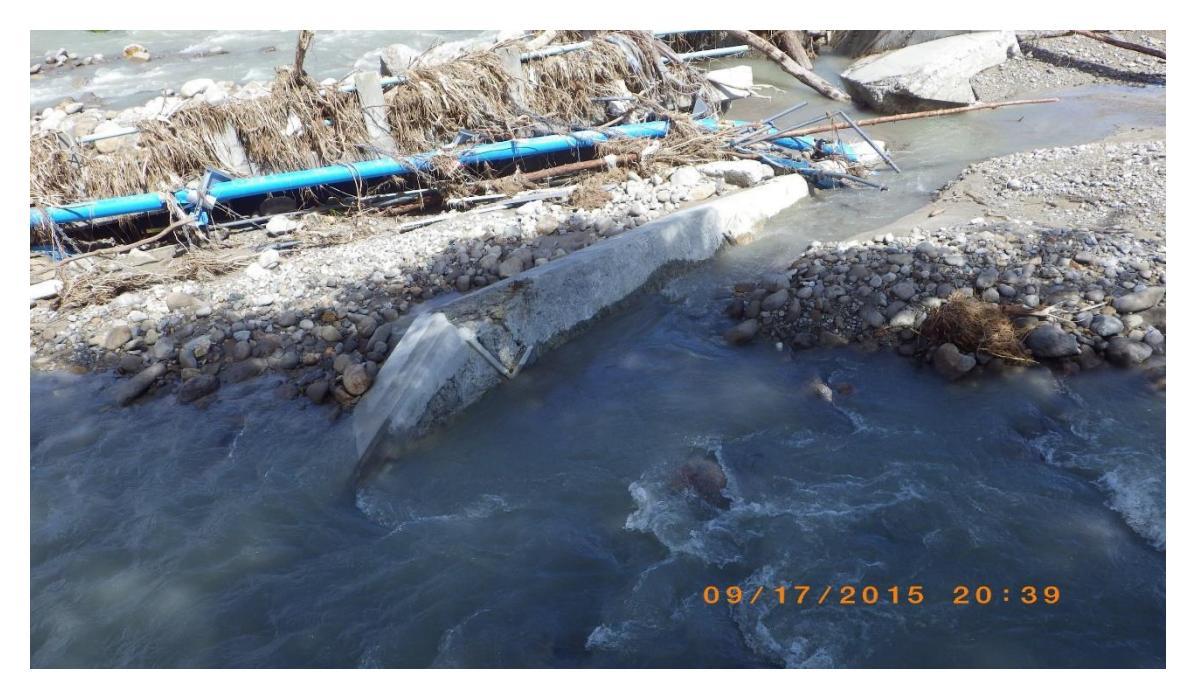
Photo 4. Takahashi Bridge. Upper surface of toppled northern pier. Taken from southern bank, east of approach.

Photo 4 shows the toppled north pier. As well as toppling, the pier is rotated 90 degrees from its original orientation. This same rotation of toppled bridge piers had been observed during bridge failure in Shizukuishi, Iwate Prefecture in 2013.

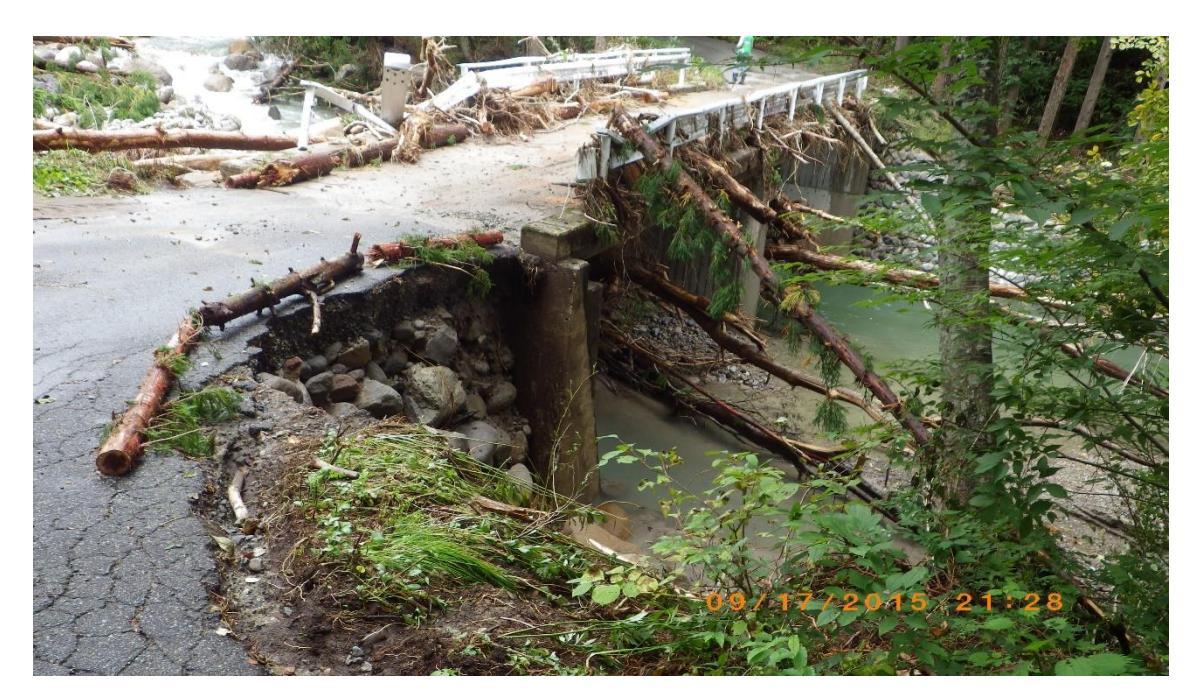
Photo 5. Mukaiyama Bridge.

Photo 5 shows this concrete girder bridge had been overtopped and dammed with debris, but it did not fail. Scour of one of the approaches began, but it did not proceed to failure because the fill behind the abutment consisted of large boulders, which were too large to be displaced by the overtopping flow.

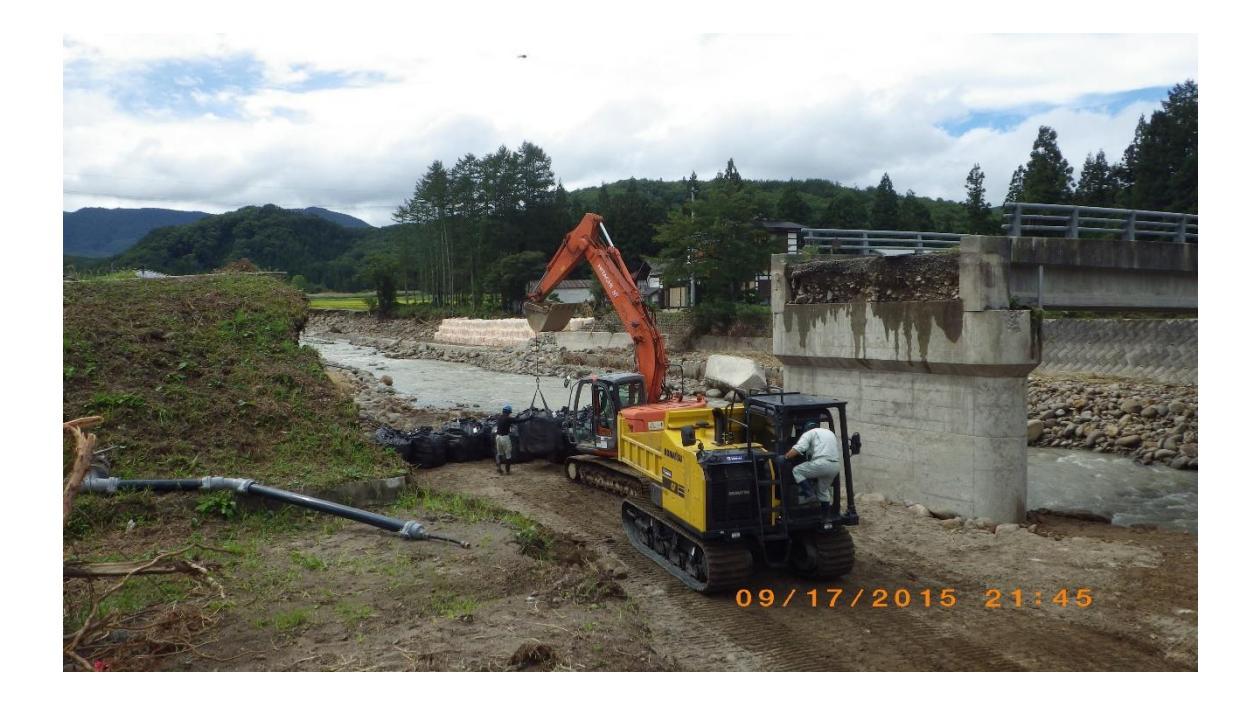
Map 2 shows the second bridge scoured in Shizukawa, about 1.5 km upstream of the Takahashi Bridge. Since construction crews were already on side, much of the evidence of the cause of failure had already been erased. It was obvious that the bridge was not overtopped, but the south approach to the bridge was nonetheless scoured away (Photo 6). The bridge itself was undamaged.

Photo 6. Shizukawa second bridge washout location, showing scoured south approach.

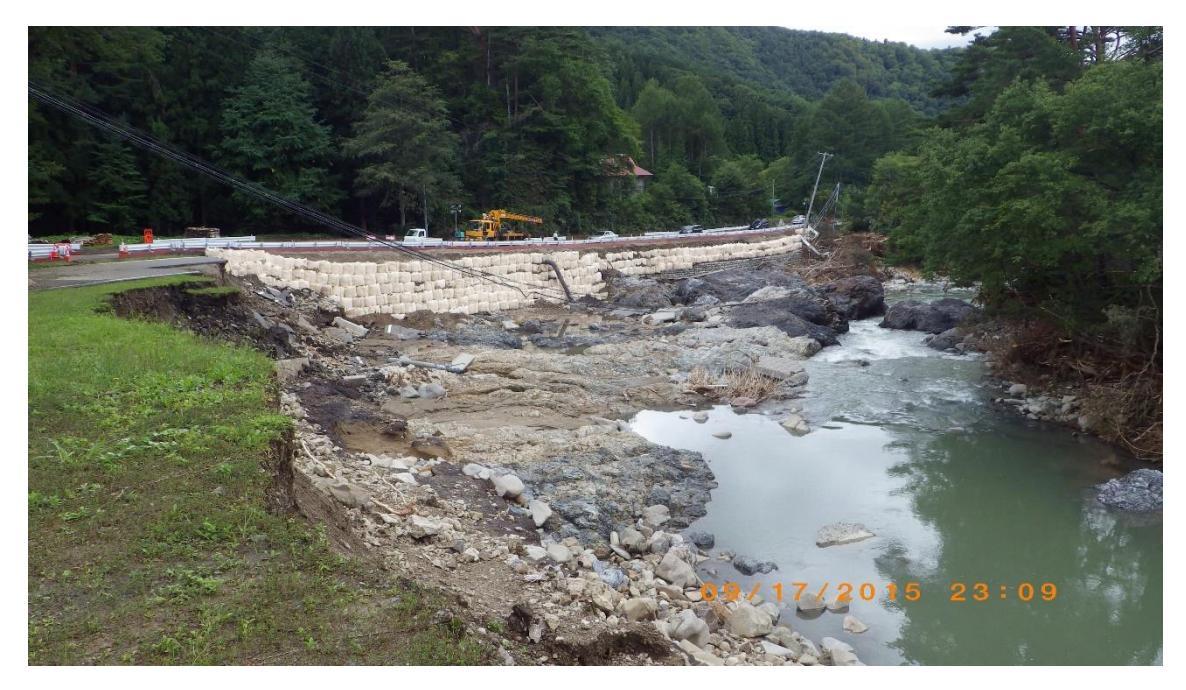
Photo 7. Washout of Highway 352.

Map 3 shows a bend in a river where Highway 352 was washed out. Photo 7 shows this washout. Most of the soil on the south bank was scoured away down to the level of bedrock. This appears to have been due to the natural river meander-building process, where the flood undercut the bank on the outside of the bend, causing it to migrate further outward.

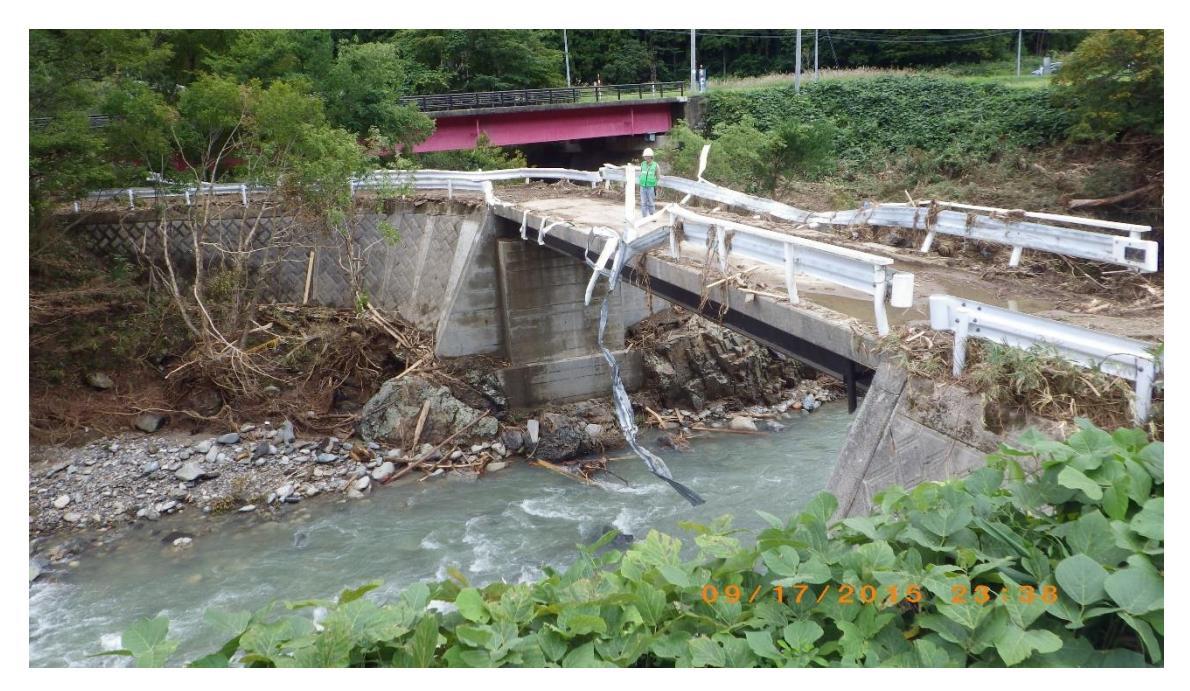
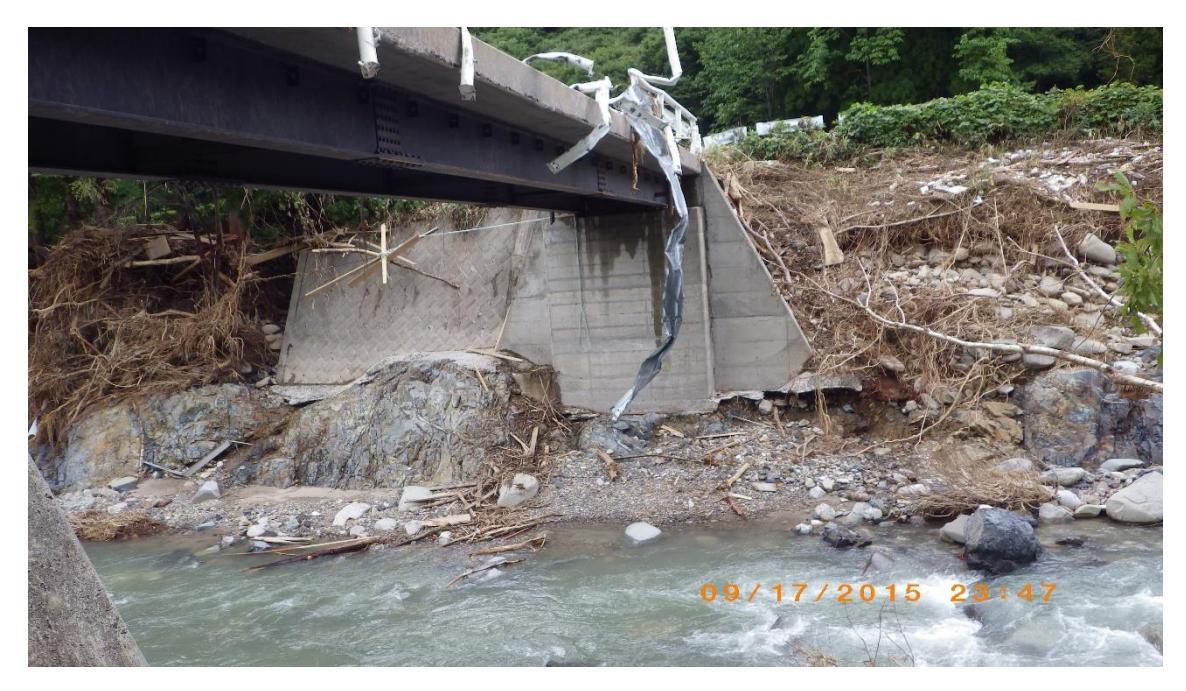
Photos 8 and 9 show the nearby Mizuishi Bridge. This steel girder bridge was submerged by the flood, but survived except for railing damage. Fine material under both abutments suffered scour, but since the abutments were founded on bedrock, the bridge survived with little structural damage.

Photo 8. Mizuishi Bridge, looking south from north bank.

Photo 9. Mizuishi Bridge, looking north from south bank.

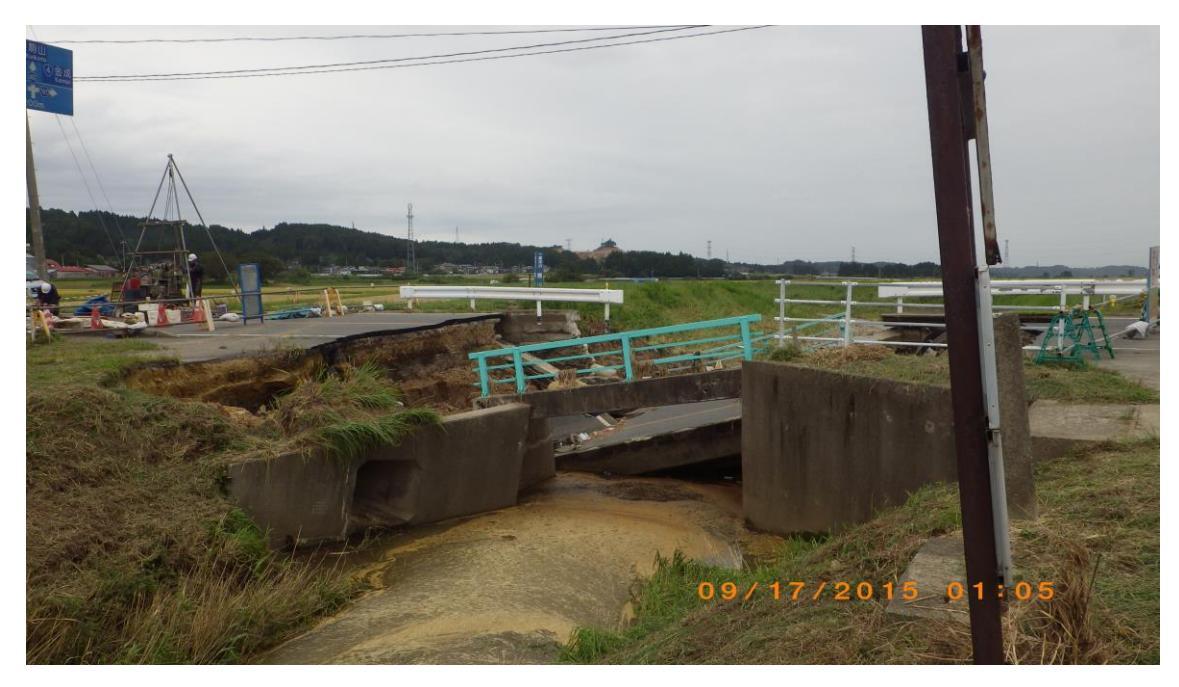
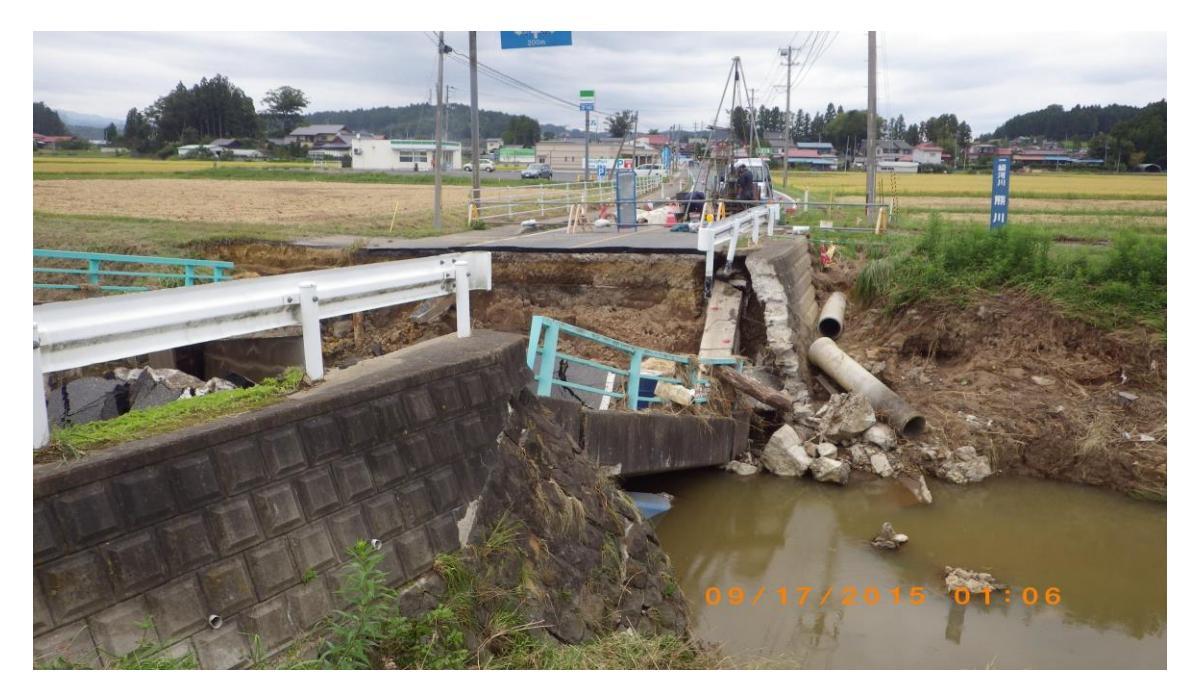
The small bridge located on Map 4 was not overtopped, but suffered scour of its north abutment (Photos 10 and 11). The abutment collapsed, causing the northern edge of the bridge deck to topple into the stream. The southern edge of the deck remained upon its abutment, but this abutment (together with the deck upon it) pulled away from the southern approach when the northern edge toppled, and then settled (Photo 12). The sidewalk west of the bridge is a separate structure (Photo 13), but failed in a similar manner, as the north approach suffered scour after the north bridge abutment failed.

Photo 10. North Miyagi bridge. Photo taken from southwest of bridge.

Photo 11. North Miyagi bridge. Photo taken from southeast of bridge.
