The EEFIT Mission to Japan after the M_w9.0 Tōhoku Earthquake: Key Findings and Lessons Learned

By A. Pomonis (Team Leader)

**Seminar on Disaster Research in the UK and Collaboration with Japan,
British Embassy in Japan, Tokyo
October 5, 2012**

THE M_w 9.0 TŌHOKU EARTHQUAKE AND TSUNAMI OF 11TH MARCH 2011 A FIELD REPORT BY EEFIT

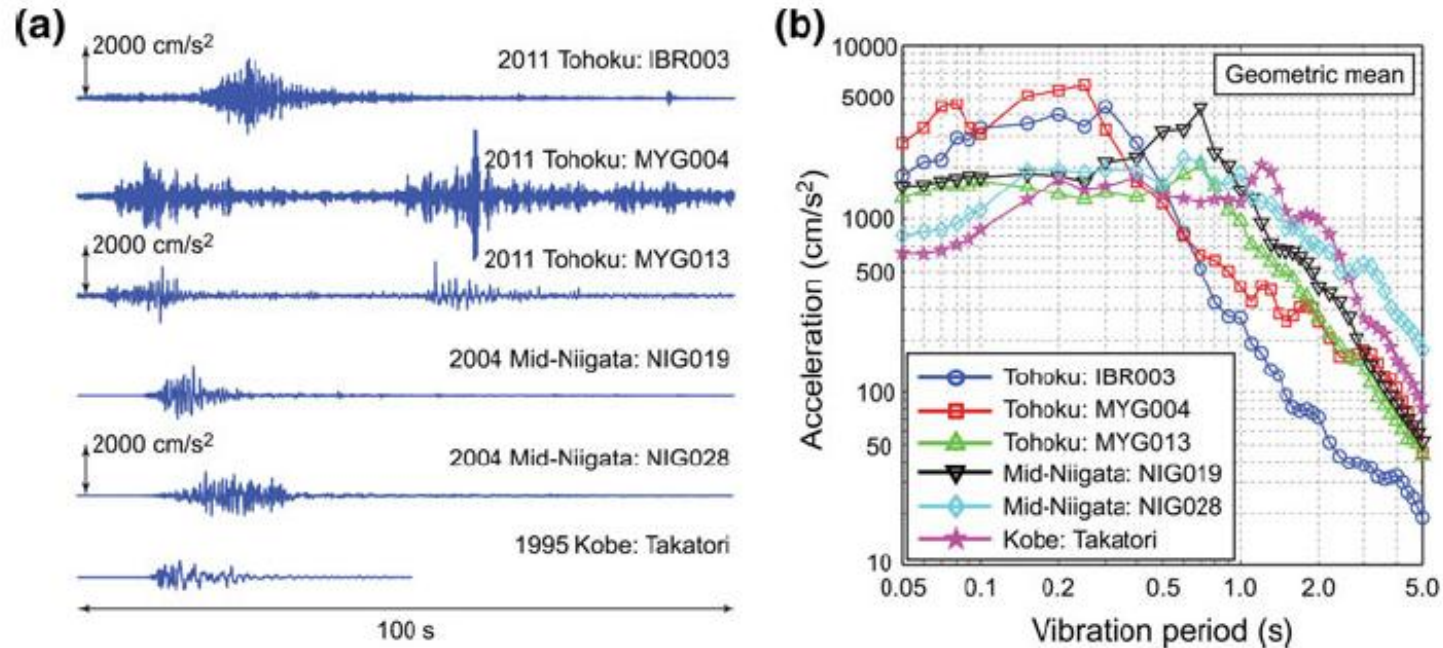
Fig. 6 Characteristics of three Tōhoku mainshock records and three significant records from the 2004 Mid-Niigata earthquake and the 1995 Kobe earthquake. a processed time-series data and b response spectra

Comparison with the recorded ground motions in 2004 Niigata-Chuetsu and 1995 Kobe earthquakes shows that the 2011 event produced motions with much greater energy content, higher peaks, higher spectral values in the lower period range (0.1-0.4s) and lower spectral values in the longer period range (0.5-1.5s).

Damage to wooden and non-wooden buildings was less severe than in Kobe.

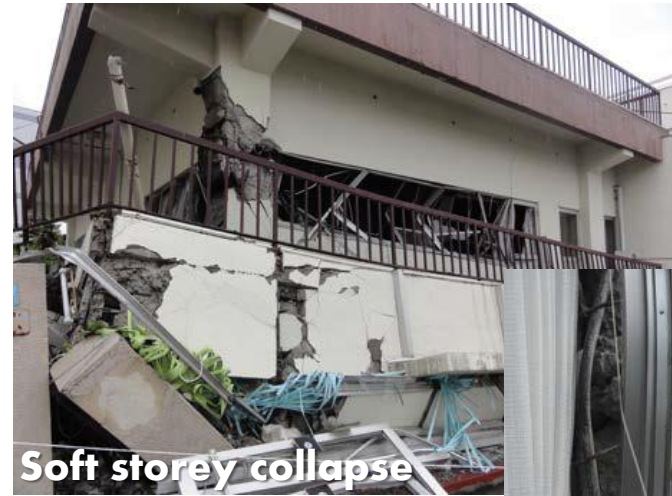
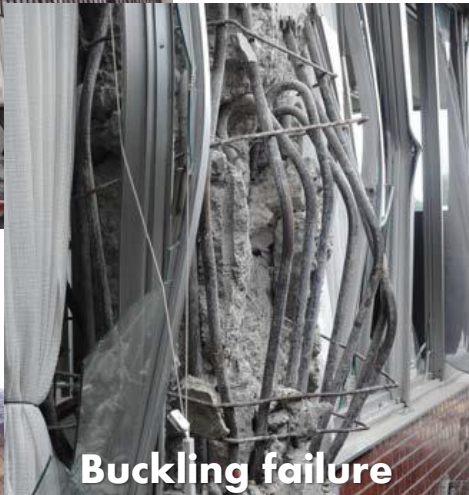
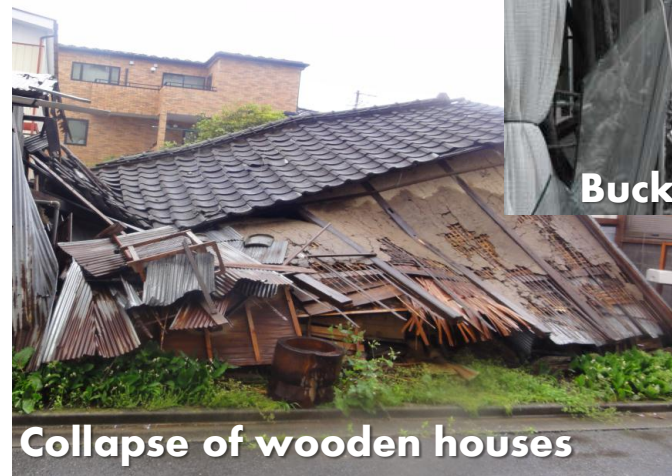
- **Post-1981 buildings performed better than older structures due to amendments to building codes.**
- **RC buildings: diagonal shear cracks and buckling of columns commonly observed in older buildings.**
- **Some high-rise buildings in Sendai will have to be demolished (one such structure was also damaged in 1978 Miyagi-oki earthq.)**
- **Old wooden structures highly susceptible to damage during strong shaking due to decay.**
- **Circa 100 deaths and 255 serious injuries occurred due to building collapse**

- **A high-rise building in Sendai damaged by the 1978 & 2011 earthquakes will have to be demolished**
- **Severe structural damage and collapse of pre-1981 RC buildings observed, but at much lower rates than in 1995 Kobe earthquake**

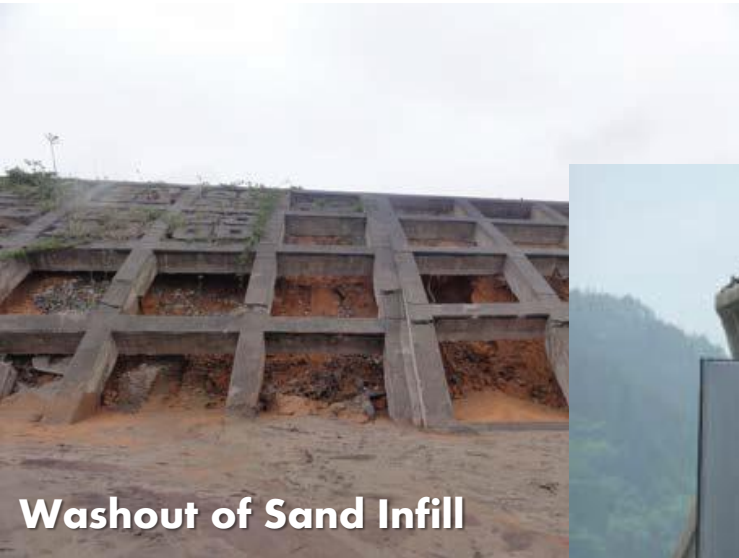
Washout of Sand Infill

- Sand infill washout and breaks in concrete lattice revetments.
- Enormous seawall failed at the “Town of Tsunami Disaster Prevention” of Tarō.
- Guinness Book of Record for deepest breakwater collapsed at Kamaishi.
- Success story at the town of Fudai; 15.5m high sluice gate suffered little damage and prevented overtopping of tsunami waves.

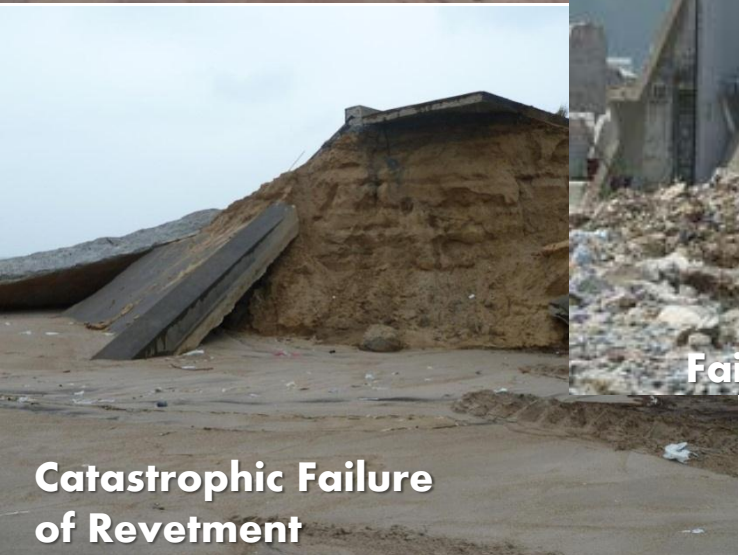
Catastrophic Failure of Revetment

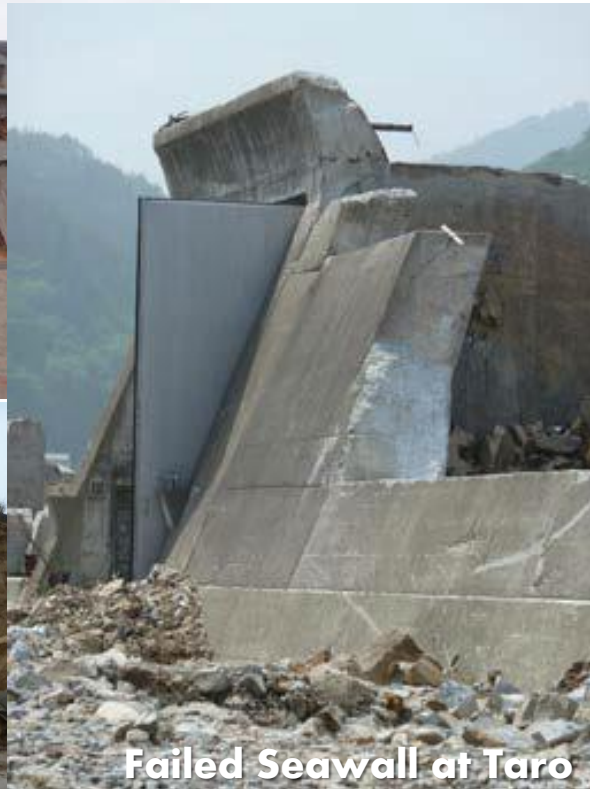
Failed Seawall at Taro

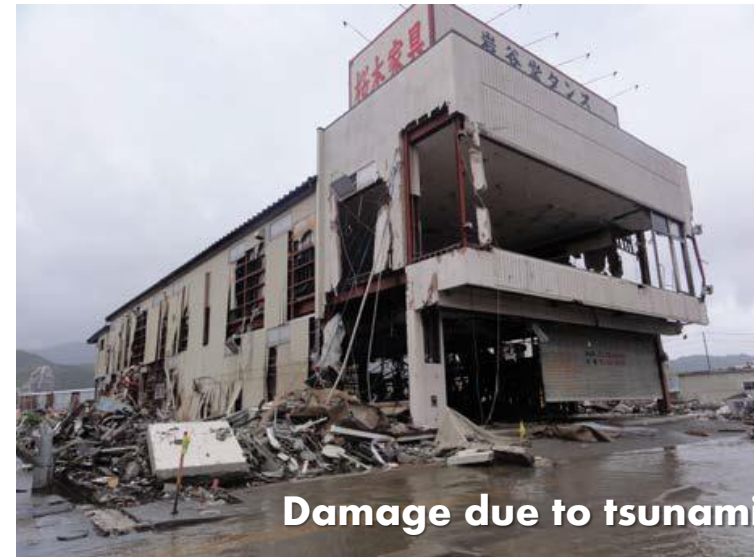
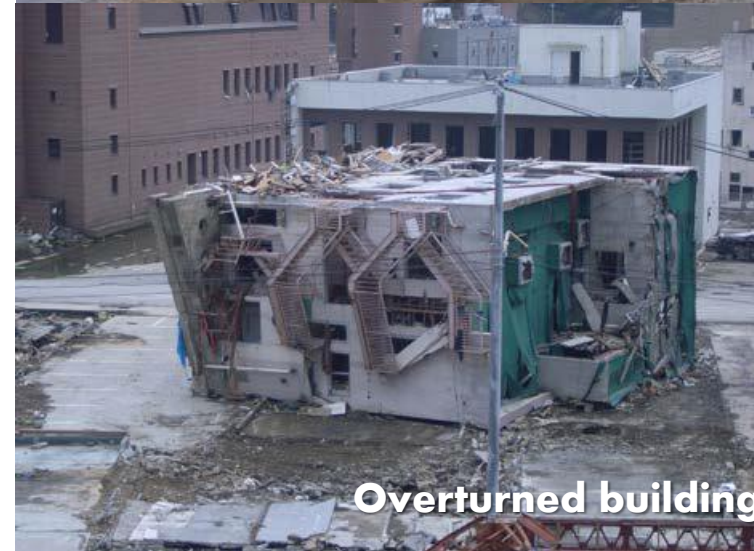
- **Tsunami height, velocity during inflow and backflow as well as debris impact are the principal factors in damage potential to buildings;**
- **Most wooden buildings were swept away when tsunami height >3 m;**
- **RC and steel frame buildings suffered extreme non-structural damage.**
- **In places of extreme tsunami height (>15 m) some RC and steel buildings of 2-4 storeys with small plan layout (some on pile foundations) were overturned and shifted up to 40m (e.g. Onagawa, Otsuchi, Miyako);**
- **Scouring due to fast-flowing tsunami around buildings reduced ground bearing support which led to tilting of buildings, e.g. Yuriage district (Natori).**

- **Wooden dwellings** are extremely vulnerable and subject to floating when tsunami height is >3m
- No-wooden buildings suffer extreme damage to non-structural elements

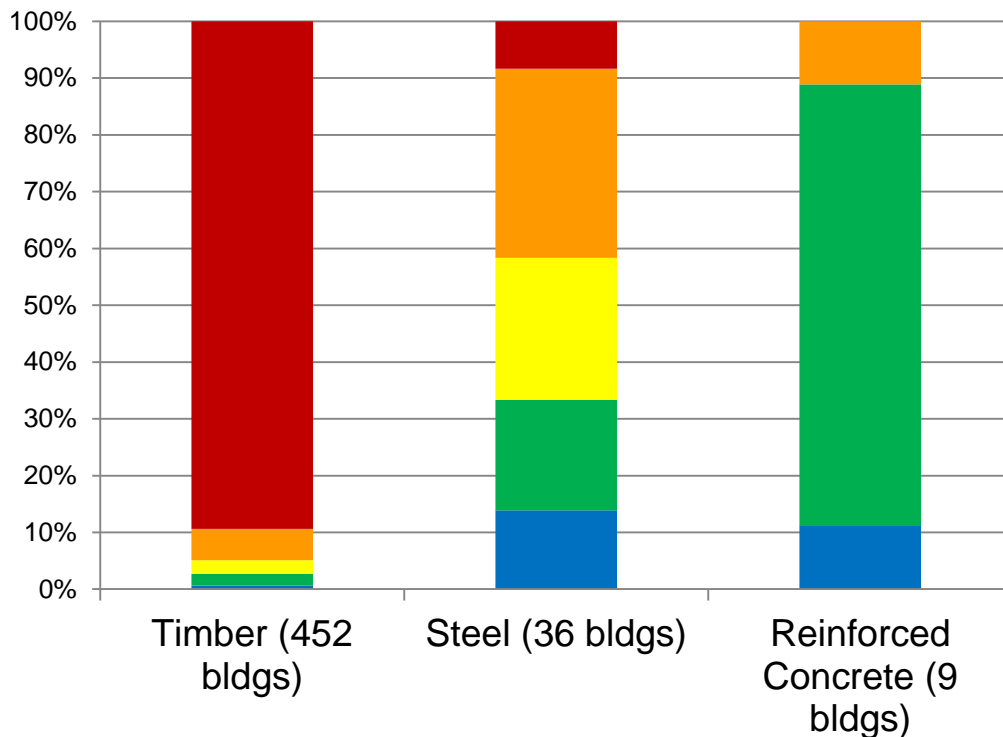
Damage level by construction type - Kesennuma

- Two detailed surveys (Kesennuma & Kamaishi)
- Kesennuma (6m flow)
- Kamaishi (6 - 8m flow)
- EEFIT (2005) damage scale used for RC build.
- New damage scale proposed for Steel and Wood frame buildings
- Damage survey maps in the report
- Significant local variations in damage
- Effect of sheltering, velocity investigated

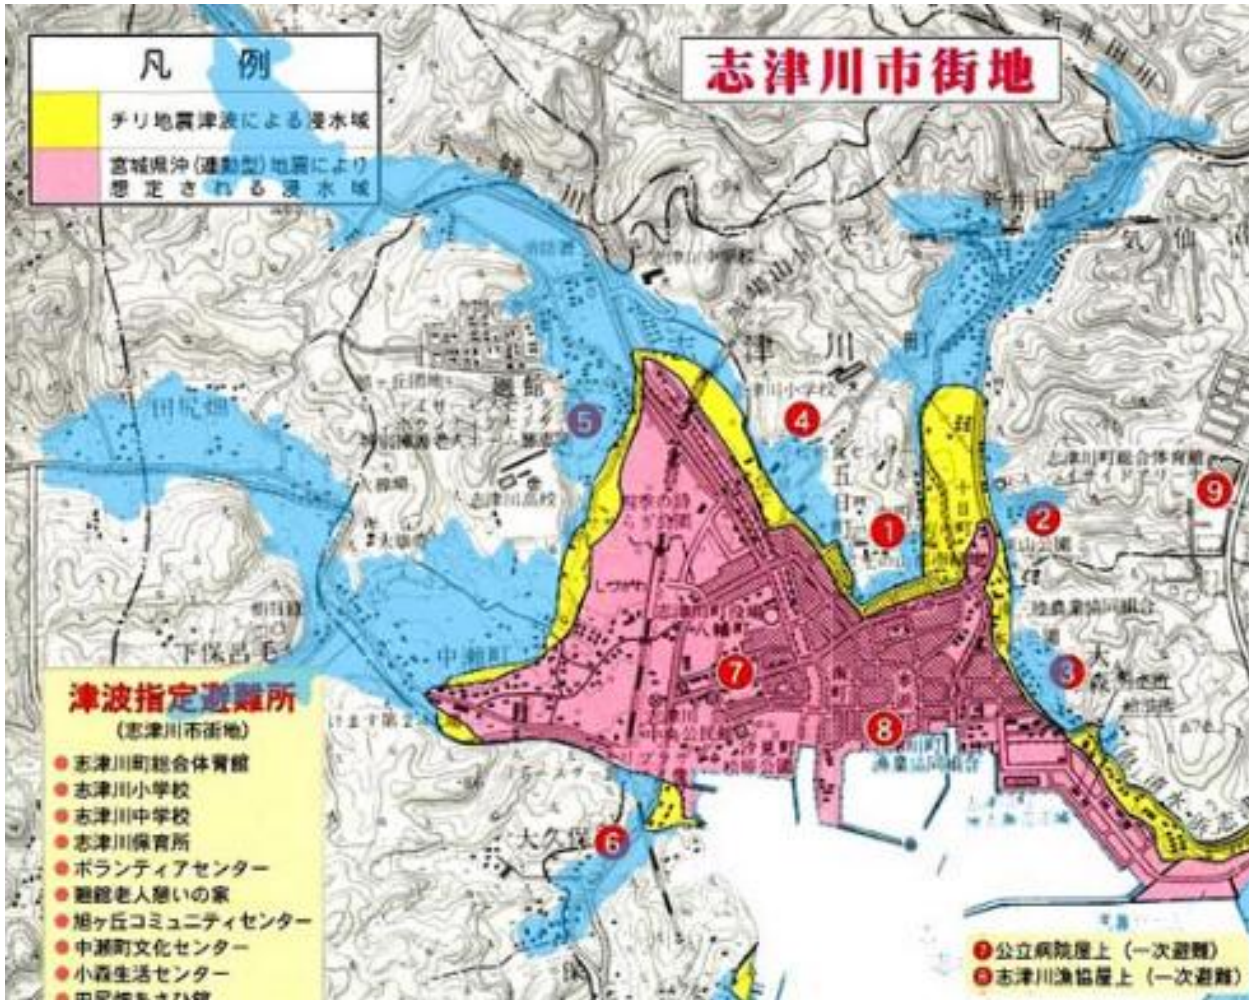
Hazard map of, **Minamisanriku**

Yellow: Maximum inundation extent from the Chile earthquake in 1960.

Pink: Expected maximum inundation extent from the Miyagi off shore earthquake scenario.

Blue: maximum inundation extent resulting from the Tohoku Earthquake.

- **Better tsunami hazard maps** needed, taking into account low-probability but high-consequence events. Evacuation planning to be accordingly developed.

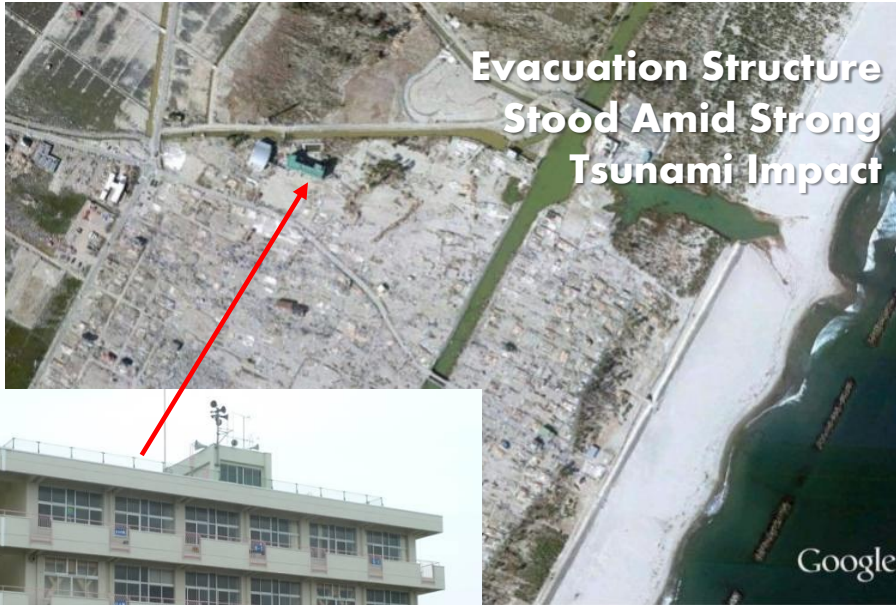
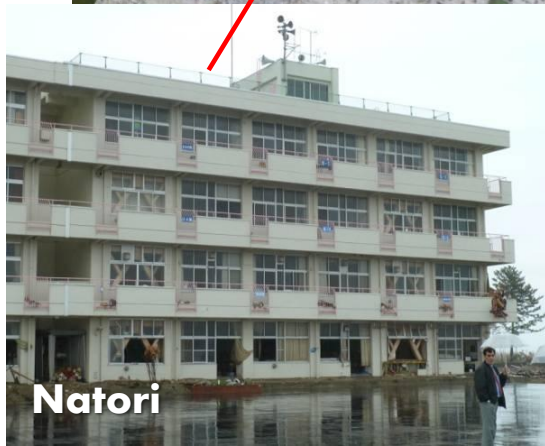
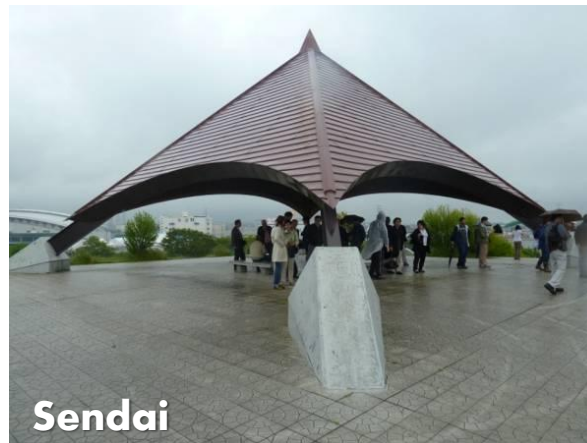
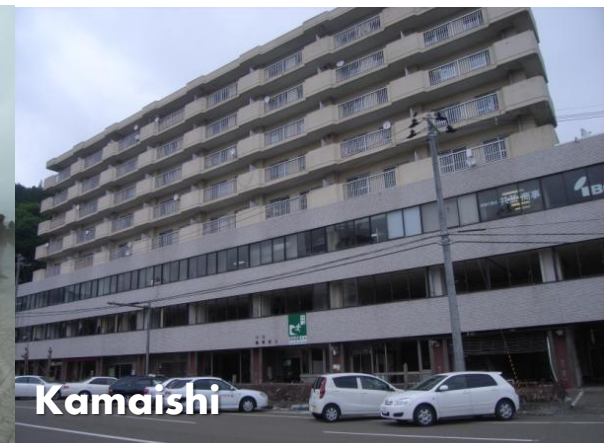
- **Most vertical evacuation structures performed well and helped reduce fatalities in tsunami affected towns and cities.**
- **Tsunami early warning and evacuation drills vital in ensuring effectiveness of the evacuation facilities.**

- Vertical evacuation structures provided safe haven to tens of thousands of people but many were situated in harm's way
- Other designated tsunami evacuation places saved hundreds of thousands, although unfortunately some were overwhelmed by the tsunami
