## Field survey of the impact of Typhoon 26 on the Sendai Coast (October 17, 2013)

Theme : Storm waves, storm surge, breakwaters, harbor

Location : Sendai Port, Arahama coast

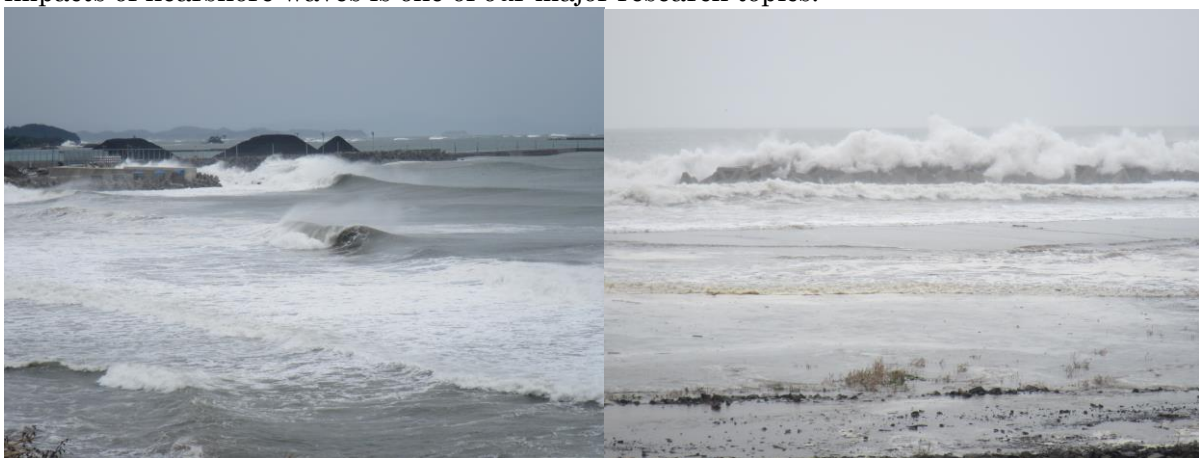
(Left) Wave overtopping of the breakwater near Sendai Shinko. (Right) Wave overtopping of tetrapod-based breakwater near Arahama Beach. Local wave runup up to the gravel road on the beach is visible in the lower part of the picture.
