**“IRIDeS Fact-finding missions to Jakarta, Indonesia”
10 – 13 February 2013**

**TOHOKU University
2013**

**Second REPORT of IRIDeS Fact-finding mission to
Jakarta, Indonesia**
10-13 February 2013

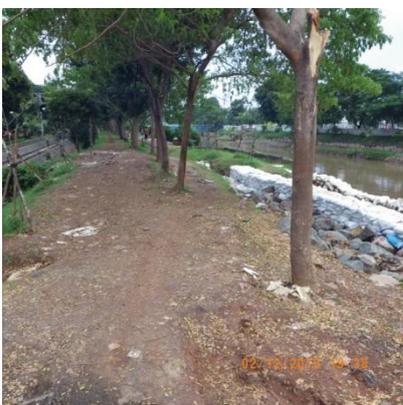
Figure 4.4.4. Trees on the canal embankment crest at the upstream end of the breach location.

Though many trees were present on the embankment (Figures 4.4.4), their roots appeared to be quite thin and short (Figures 4.4.5), and thus unlikely to reach across the entire embankment width. Piping due to decayed tree roots is therefore unlikely to have been a cause of embankment failure, but the possibility cannot be entirely neglected. As such, the inspection of the entire embankment for the possibility of decayed tree roots (often indicated by dead trees or stumps), along with the removal and backfill of these roots, is an action item which the entity responsible for embankment maintenance should pursue (USACE, 2000).

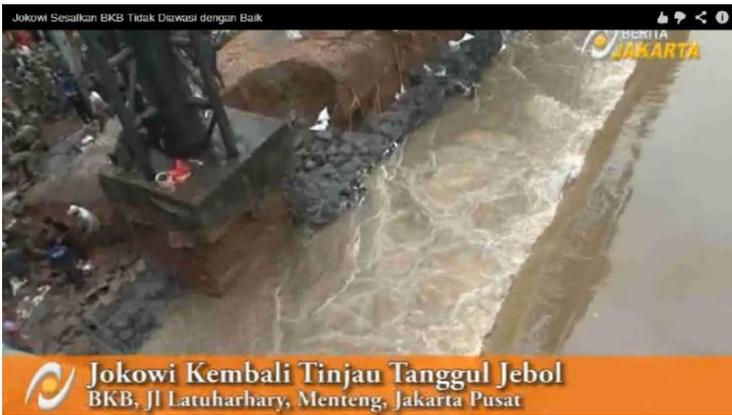
Figure 4.4.5. Video capture image from Jakarta News, showing overtopping of the concrete wall (at water level 3), tree roots in the canal embankment crest, and a tower foundation encroaching on the embankment.

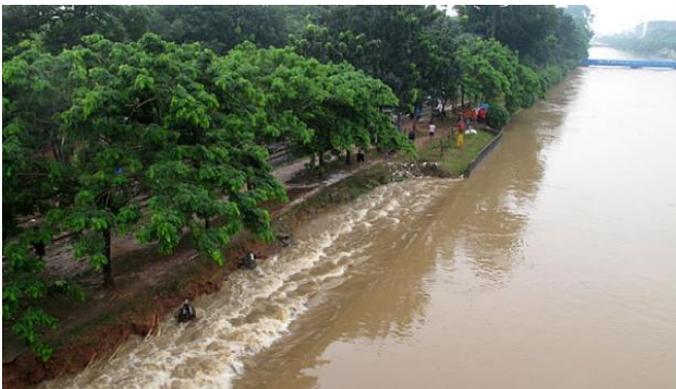
Figure 4.4.6. Photo looking upstream by Hengki Eko Putra during canal failure. Note that the parapet wall on the upstream end of the breach drops in elevation through the breach site.

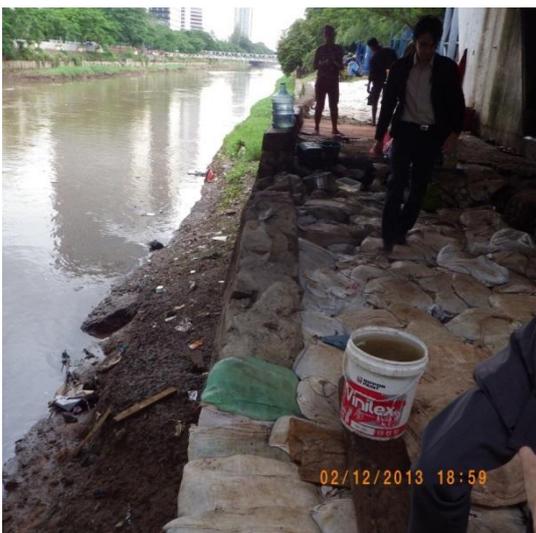
Figure 4.4.7. Downstream end of breach site, looking downstream (west). Note the remains of masonry atop the concrete wall between the sandbags and the parapet wall downstream. Note also that the parapet wall rises in elevation downstream of the breach site.

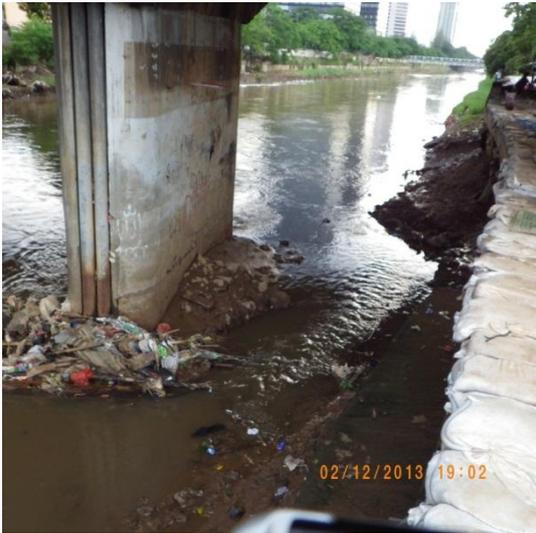
Figure 4.4.8. Highway bridge pier in West Drainage Canal beside breach, looking downstream.

The possibility of a local increase in water level at the breach site is analyzed by assuming the bridge pier of Figure 4.4.8 is dammed with debris enough to cause local stagnation of the flow there. Using the data of Deltares (2013) outlined for the bank erosion analysis above and assuming a Manning's $n=0.025$ (Arcement & Schneider, 1984), the mean flow speed in the canal during flood was approximately 2.6 m/s. Stagnation flow depth increase can be estimated from the conversion of flow kinetic energy to potential energy shown by Equation (4.4)

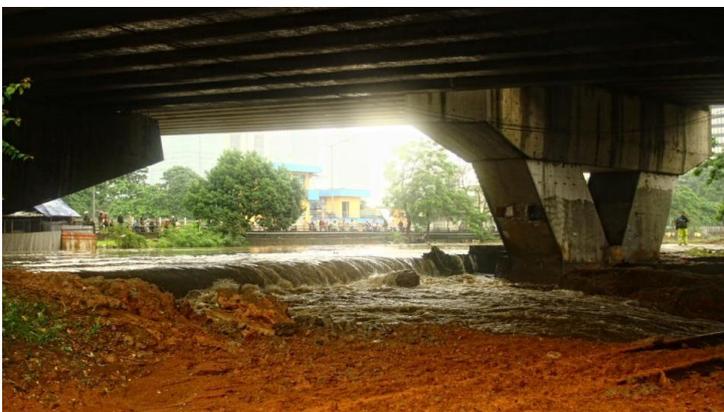
Figure 4.4.10. Photo by Hengki Eko Putra during canal failure. Note the bridge pier on the embankment at the downstream end (right-hand side) of the breach.

A local drop in the embankment crest was observed downstream of the breach, apparently centered on the in-embankment bridge pier of Figure 4.4.10. Here, the embankment crest was many 10's of centimeters lower than the embankment crest further downstream or upstream. Locals corroborated that before the flood, this local dip in elevation continued through the breach section. They also said that before the flood there was further reduction of the embankment crest height below the gap between the two highway bridges at the site (Figure 4.4.11), due to rainwater drainage from the bridges impinging on the embankment crest, though this could not be verified in our own observations.

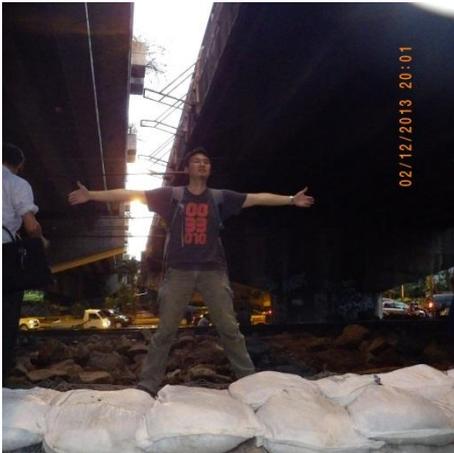
Figure 4.4.11. Gap between the two highway bridges above the embankment breach site.

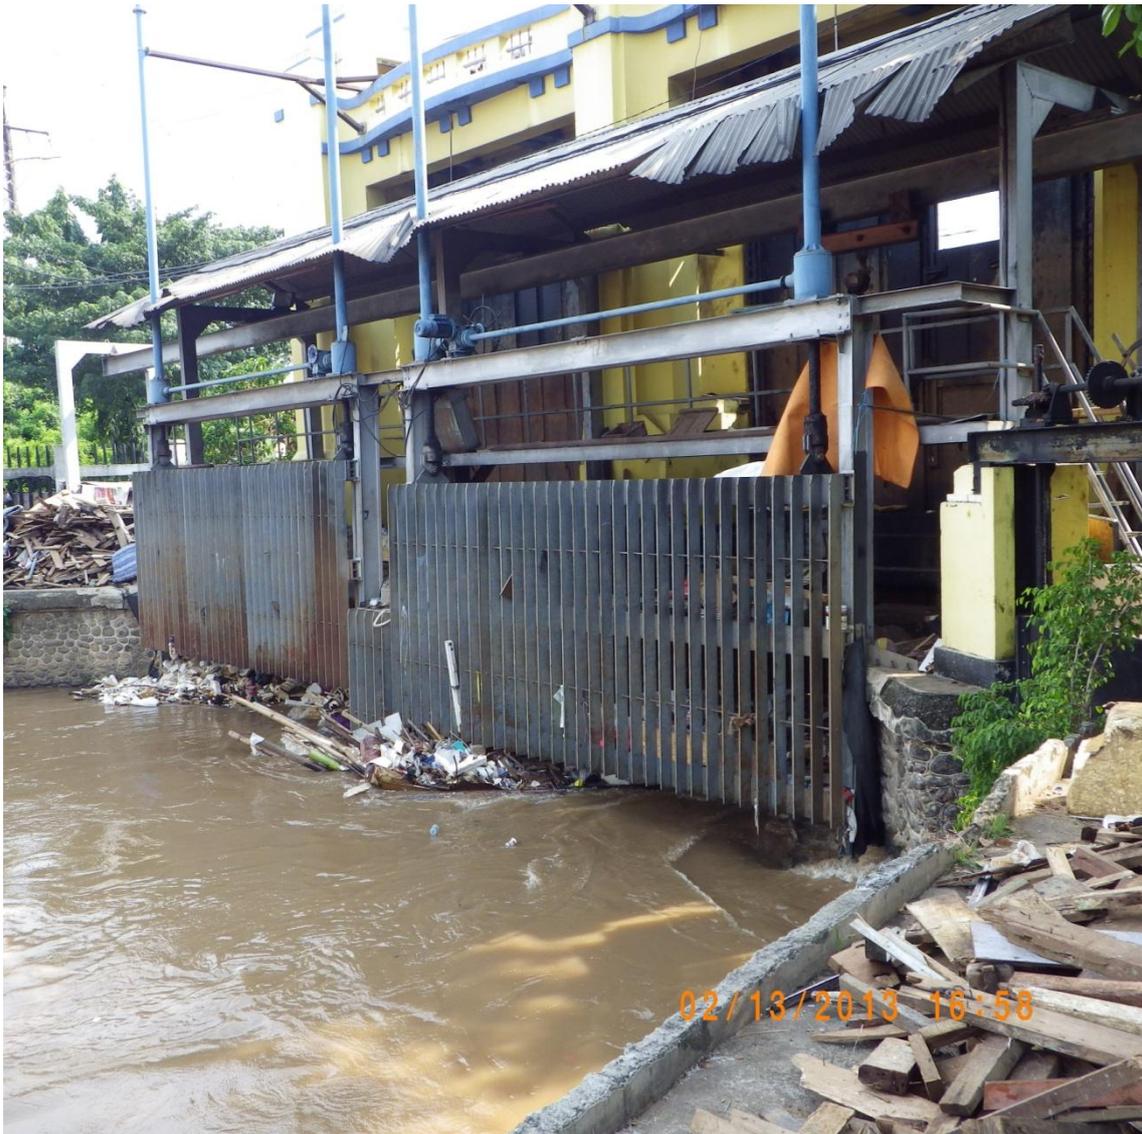
Figure 4.5.1. Floating trash at the entrance to the Mangalai (west drainage canal) lift gates. These gates are always open, as the west drainage canal is the main pathway for water from the upper Ciliwung River to reach the ocean.

During a flood, it's possible that so much trash accumulates that the flow capacity of the Mangalai (west drainage canal) gate, and the similar Karet gate, are reduced. In fact, 3 of the 4 openings of the Karet gate (no photo available) were reported by Deltares to have been entirely clogged by trash during the January 2013 flood. If this indeed had been the case, it's possible that reduced flow capacity of the Karet gate caused backwater into the west drainage canal, and that this backwater resulted in a water level high enough to cause overtopping and failure of the west drainage canal embankment, which henceforth resulted in severe and unexpectedly rapid flooding of Jakarta's commercial center, and two ensuing deaths.

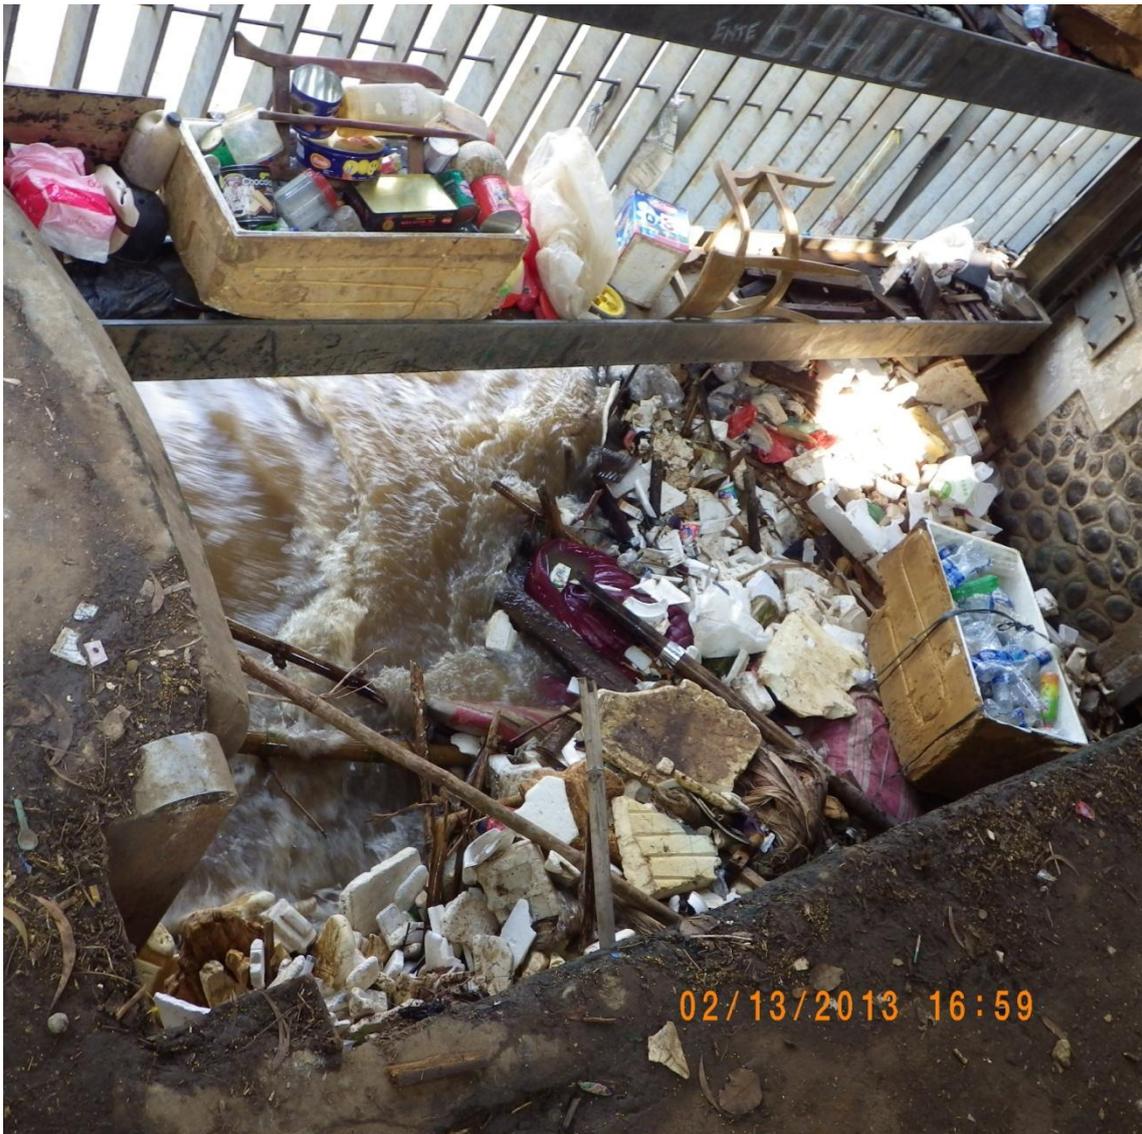
Figure 4.5.2. Floating trash accumulating at the Mangalai (west drainage canal) gate, where flow dives into the gate opening.

Likewise, reduction of flow capacity of the Mangalai (west drainage canal) gate due to clogging by trash could have caused backwater into the upper Ciliwung River, possibly resulting in overtopping of the Mangalai (Old Ciliwung River) gate, or a water level at this gate dangerously high enough to have prompted the operator to open the gate in order to relieve stress on the gate and prevent failure of the structure or of the canal embankments downstream.

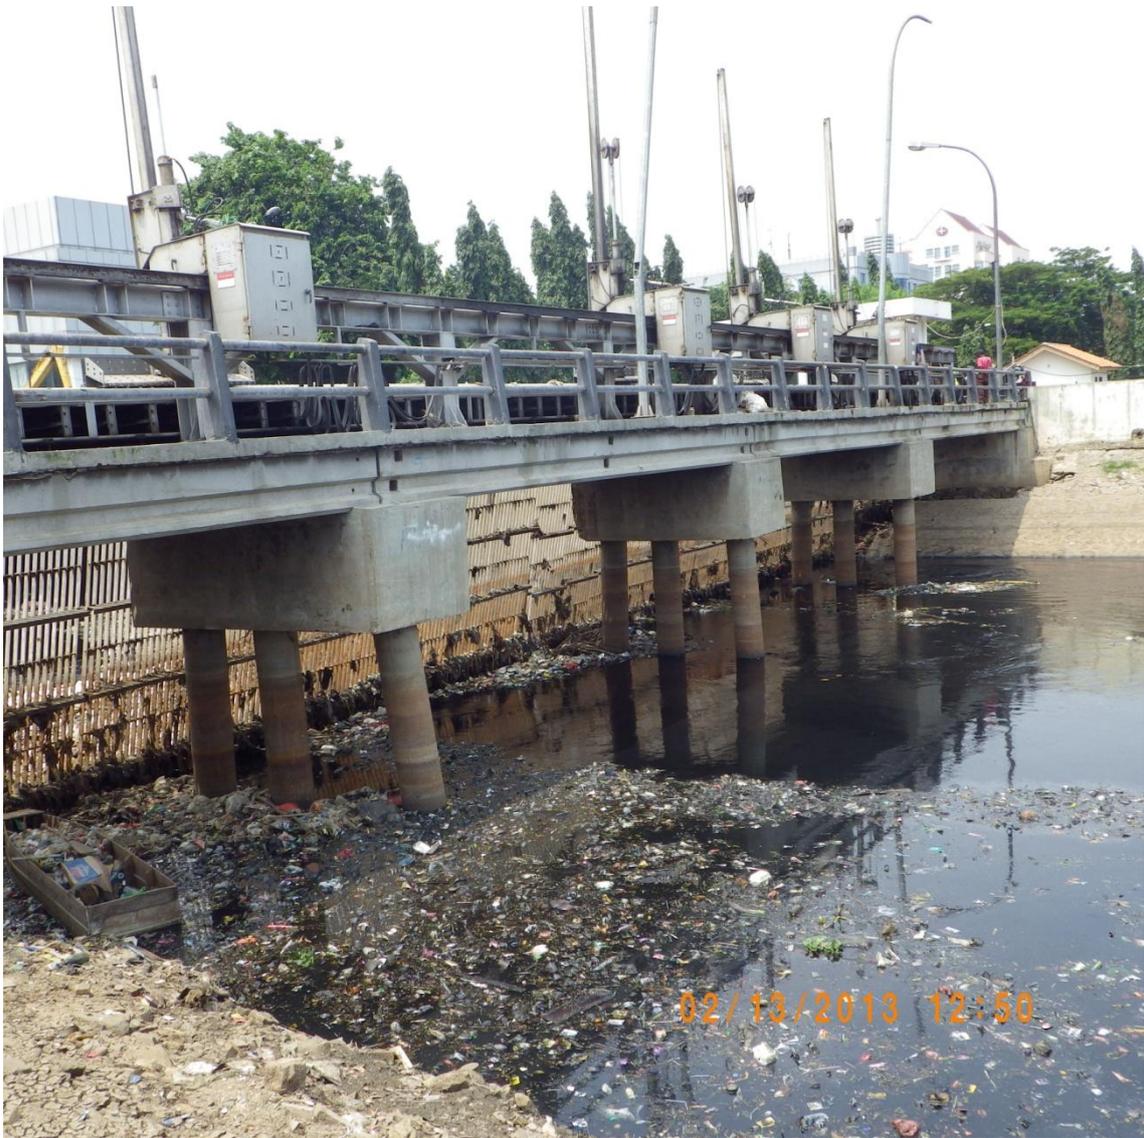
Figure 4.5.3. Trash screens at the entrance to Pluit sump. Were these screens raised during the January 2013 flood, to prevent backwater due to debris damming of the screens? Is this SOP?

Figure 4.5.3 shows trash accumulating at the entrance to Pluit sump. At this time, trash screens were closed. Assuming reasonable SOP, trash screens would be open during floods, so as not to cause backwater into the drainage canals. However, as Figure 4.5.4 shows, trash can accumulate on piers, and cause debris damming resulting in backwater upstream into the canal. Trash can also accumulate on the drop structure entering Pluit sump (Figure 4.5.5), also causing backwater into the canal.

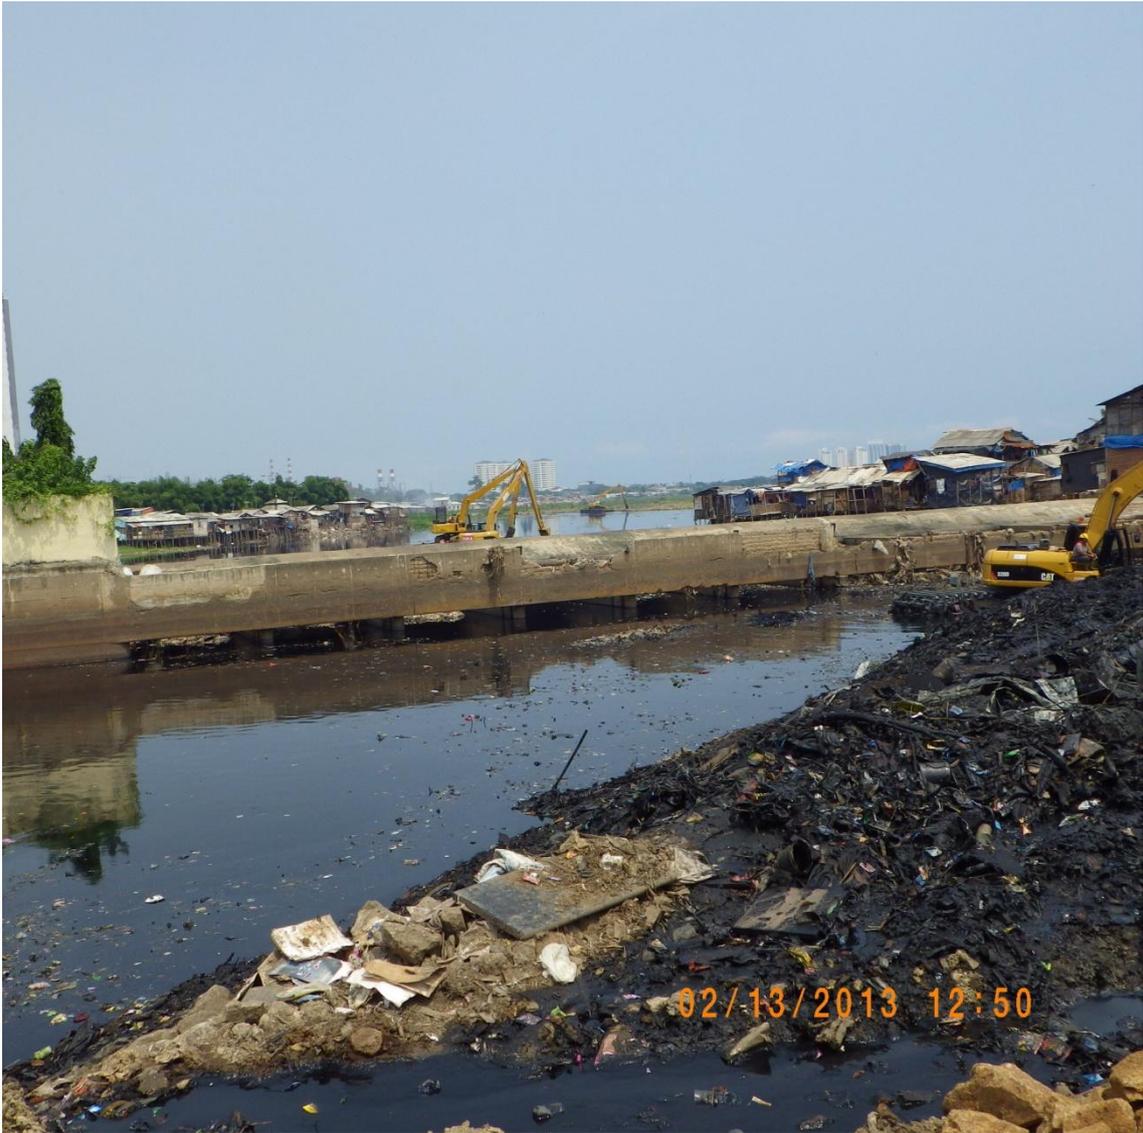
Figure 4.5.5. Drop structure entering Pluit sump.

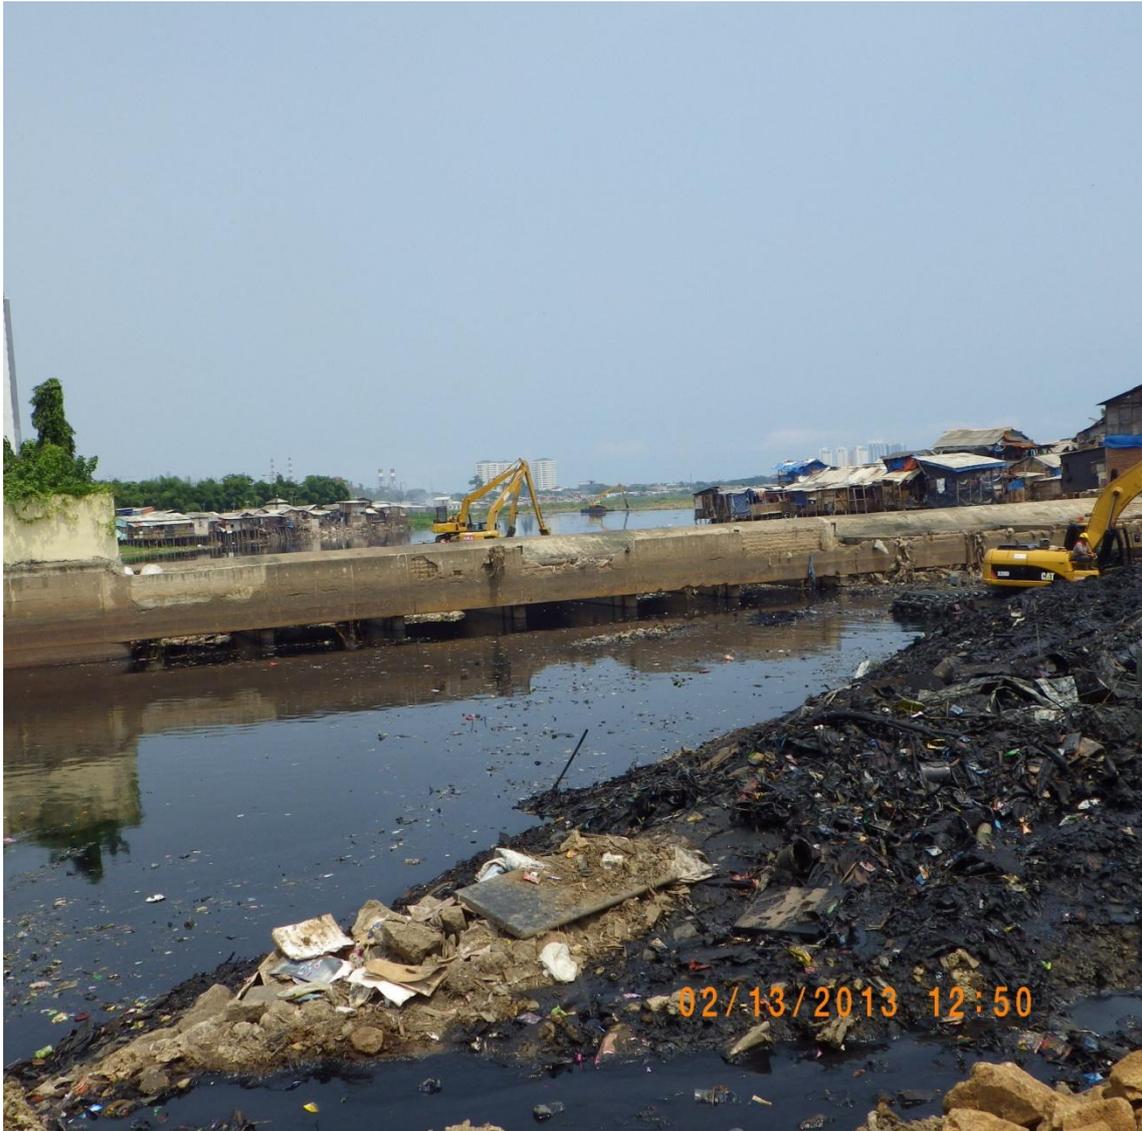
Figure 4.6.1. Dredges operating at the entrance to and inside Pluit sump.

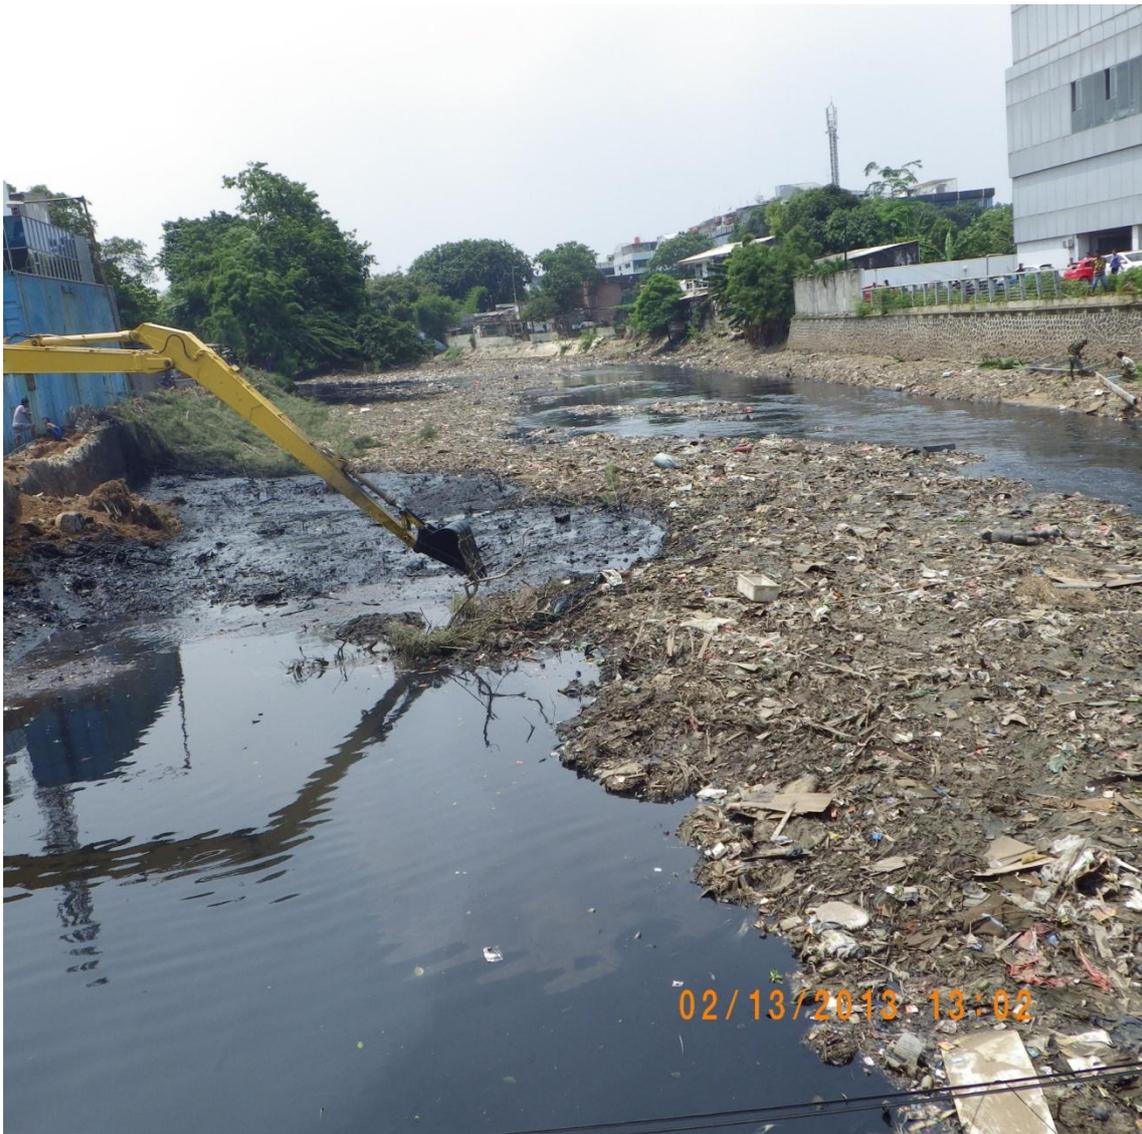
Figure 4.6.2. Sedimentation and trash in the canal leading into Pluit sump.

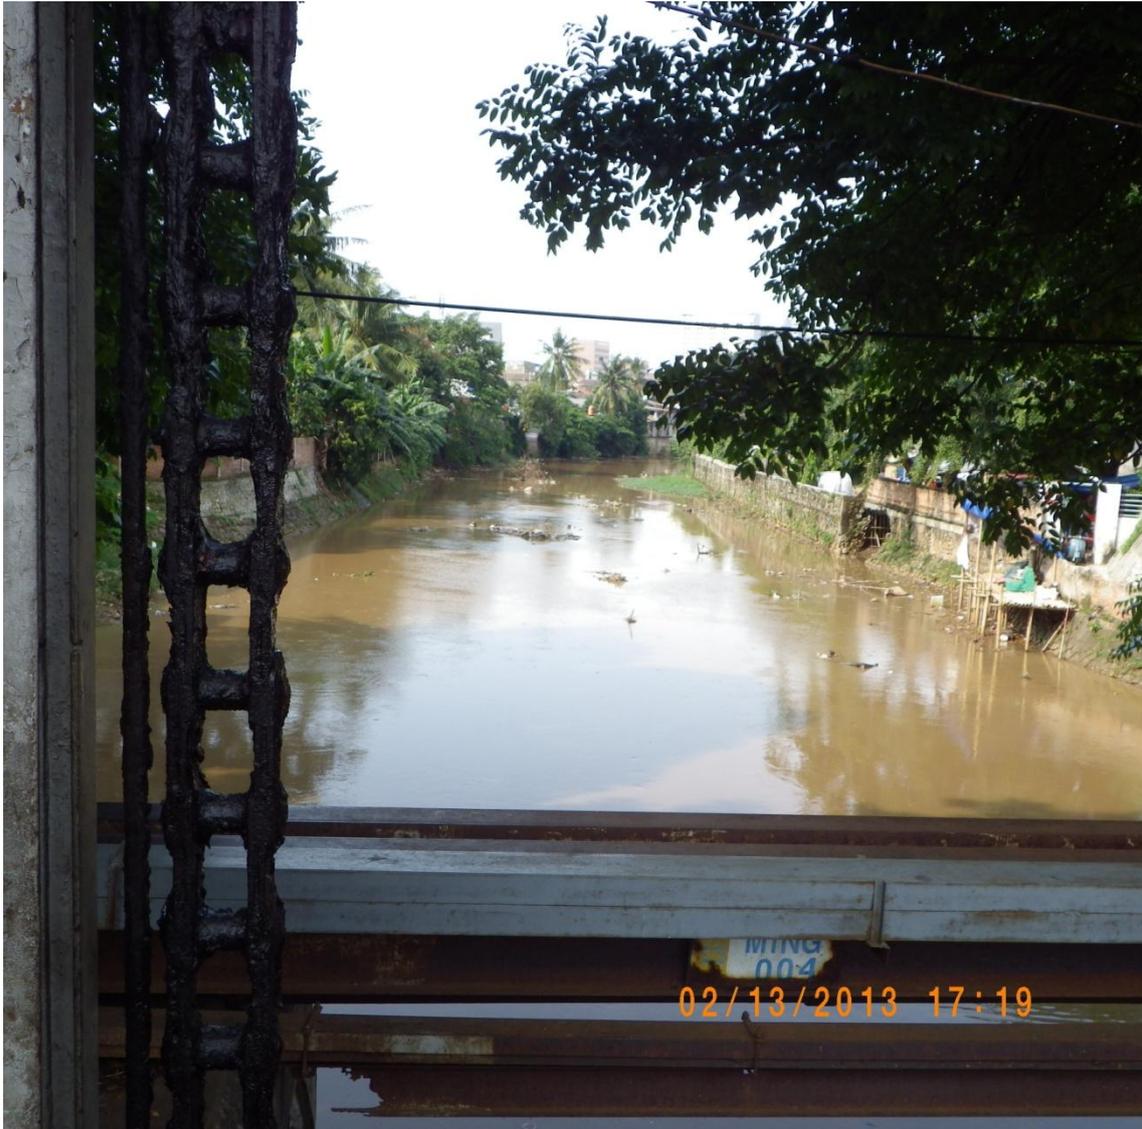
Figure 4.6.3. Sedimentation and trash “islands” in the Old Ciliwung River just below the closed diversion gate. The presence of so much trash just downstream of the closed gate indicates that the gate may have been either opened or overtopped recently.

Sedimentation and trash accumulation in the Old Ciliwung River and local drainage canals inside the city is also problematic (Figure 4.6.3), as elevated water levels in these canals prevents drainage of rainfall to Pluit sump, causing flooding of surrounding areas. The specified capacity of the Old Ciliwung River is 50 m³/s, but this small flow rate is further reduced due to sedimentation, and is thus one of the likely culprits in the January 2013 flooding of Jakarta's governmental center.

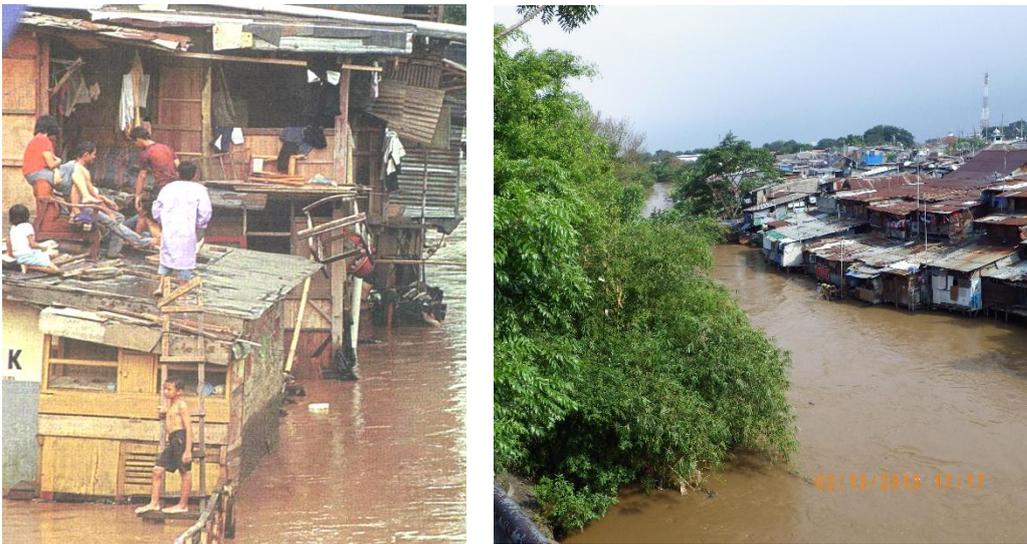
Figure 4.7.1. Illegally constructed houses in Jakarta's river channels and drainage canals.

Illegal development in river channels, canals and floodplains such as construction of houses (Figure 4.7.1) in these areas may be contributing to reduction of the flood-carrying capacity of these river channels and canals and the overall drainage capacity of Jakarta city. Jakarta's drainage system should be evaluated using a hydrologic/hydraulic model considering not only sediment and trash deposition on the river bed and clogging gates, but also considering the effect of illegally constructed structures on flow capacity in the river channels. In addition, this illegally inhabited zone is easily inundated and houses built in the zone are easily flushed away during floods. This is an important social issue to be considered for future flood management and Jakarta city development plans.

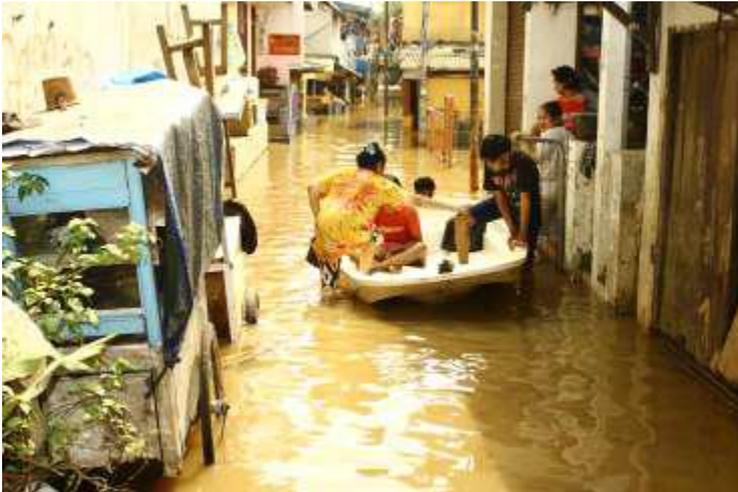
Figure 7.1.1.4. Evacuation of people living nearby the Ciliwung River due to the 13 February 2013 flood.

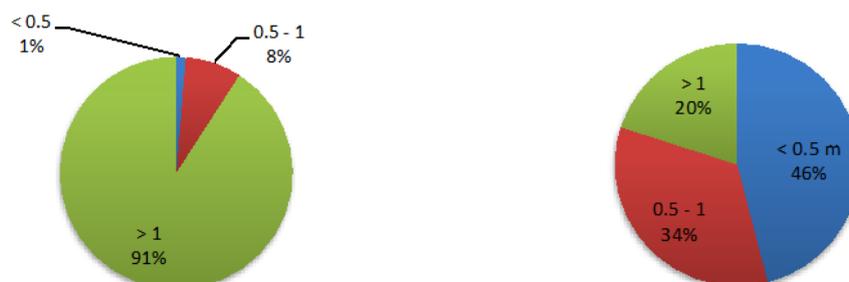
Estimated maximum flood height

Figure 7.1.2.8. Predicted maximum height of future flooding as estimated by the respondents.

The experiences described above affect the estimated future maximum flood depth predicted by the respondents. Students from the second group think that flooding in their area will not exceed 0.5 m, as has happened so far. Similarly, past experiences yield a maximum flood depth of more than 1 m in the future as estimated by almost all respondents from the first group (Fig. 7.1.2.8).

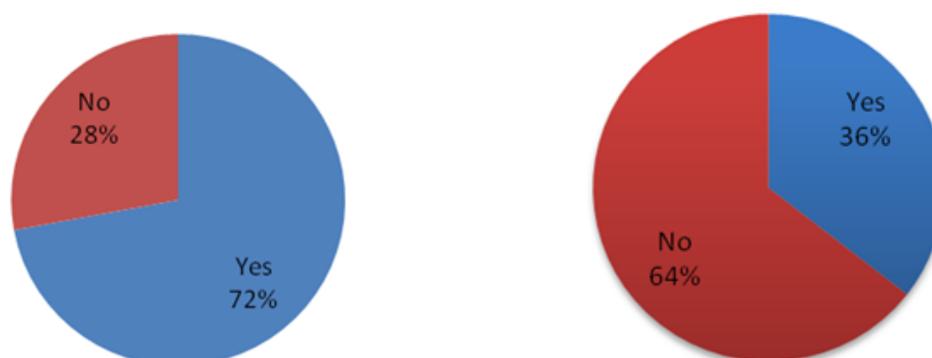
Do you think flood can threatening your safety?

Figure7.1.2.17. Public perceptions about the dangers of floods.

To explore in more detail the perception of flood risk related with the above presented results, we posed several questions to elaborate people's opinions about flooding in their area. We first asked whether or not the respondents felt that flood can threaten their safety. Interestingly, we found a contradictory result between the first and the second groups. By having experiences several big floods, a majority of respondents in the first group said that flood is threatening to their safety (72.1%). However, 64% of respondents from the second group said the flood cannot harm them (Fig. 7.1.2.17).

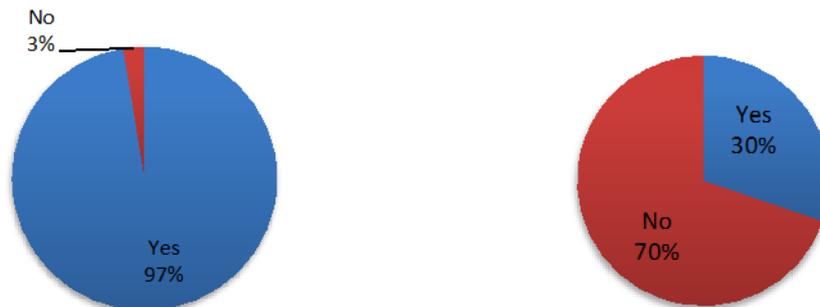
Did you receive information before 2013 flood arrived in your area?

Figure 7.1.2.21. Availability of flood early warning during the 2013 flood based on information from respondents in the first group (left) and people from the second group (right).

It can be seen that people in the first group received information before the flood arrived in their area, while most of people in the second group did not. Thus, we first assumed that flood early warning is indeed available along the Ciliwung River. Our assumption was strengthened by a report on the development of flood early warning in Jakarta named PROMISE (PROMISE, 2009). This system was preliminarily applied in two areas: Kebun Baru and Bukit Duri, where the latter is one of the locations where the

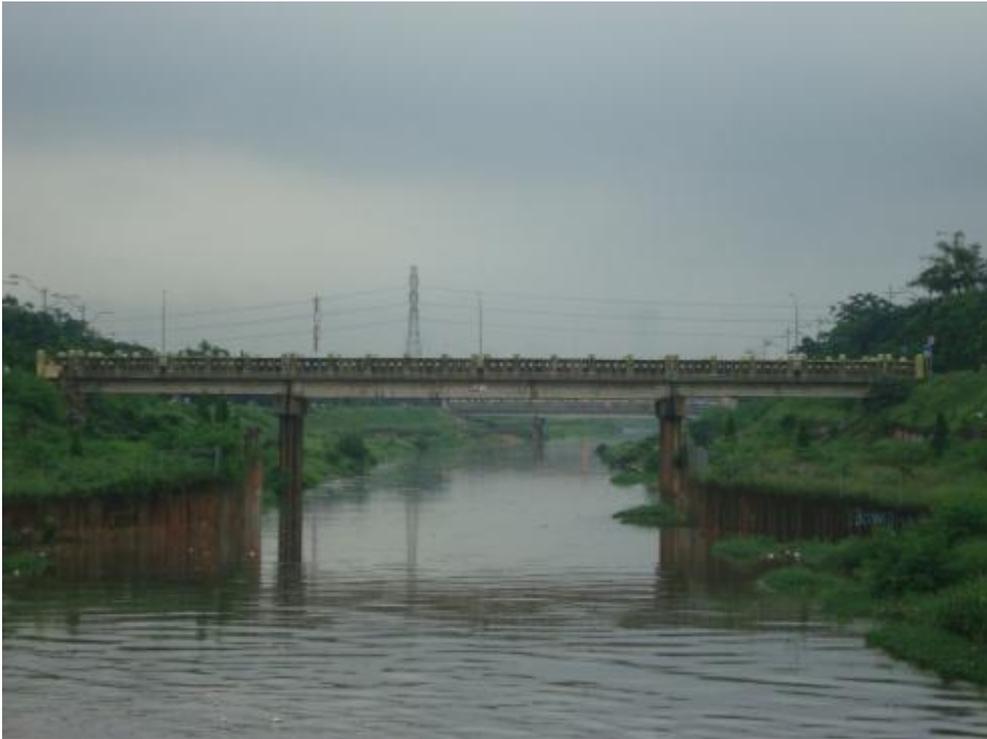
Figure 7.3.1. Flood water level of the East drainage canal.

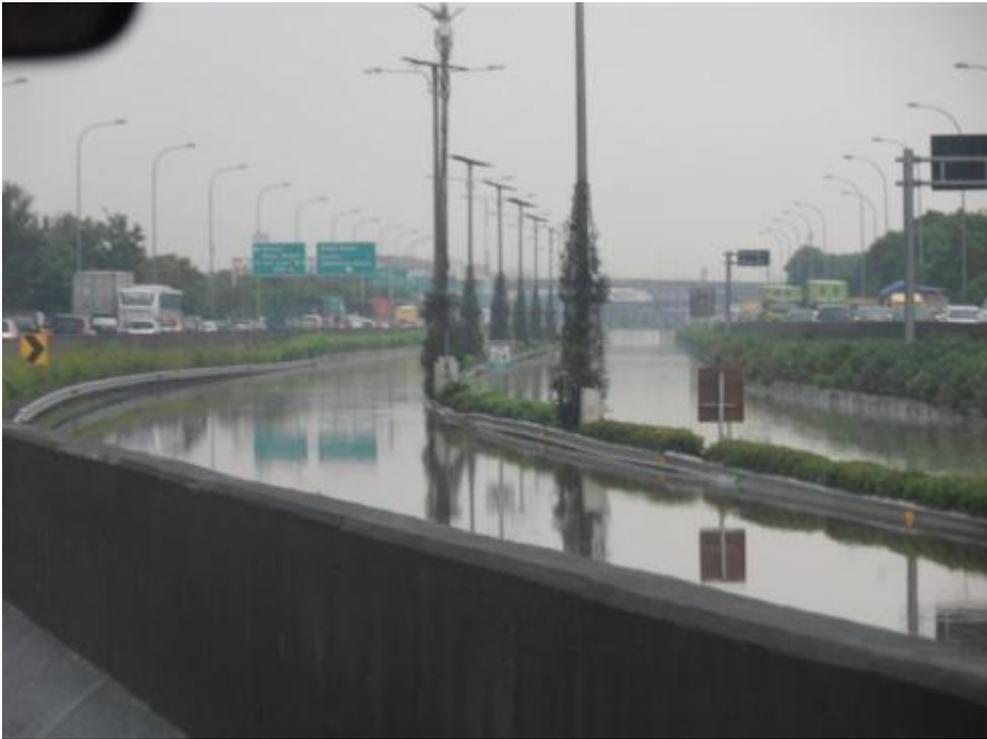
Figure 7.3.2. Flooded road to Jakarta Airport.

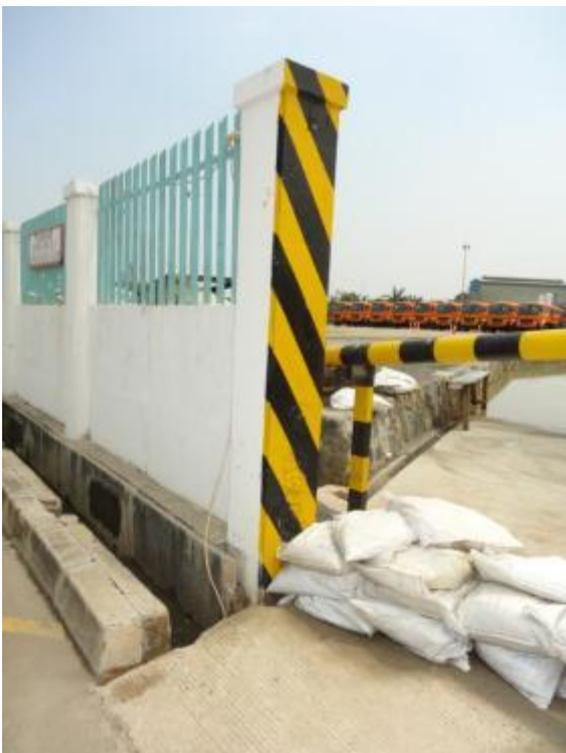
Figure 7.3.3. Strong reinforced concrete wall as countermeasure against flood.

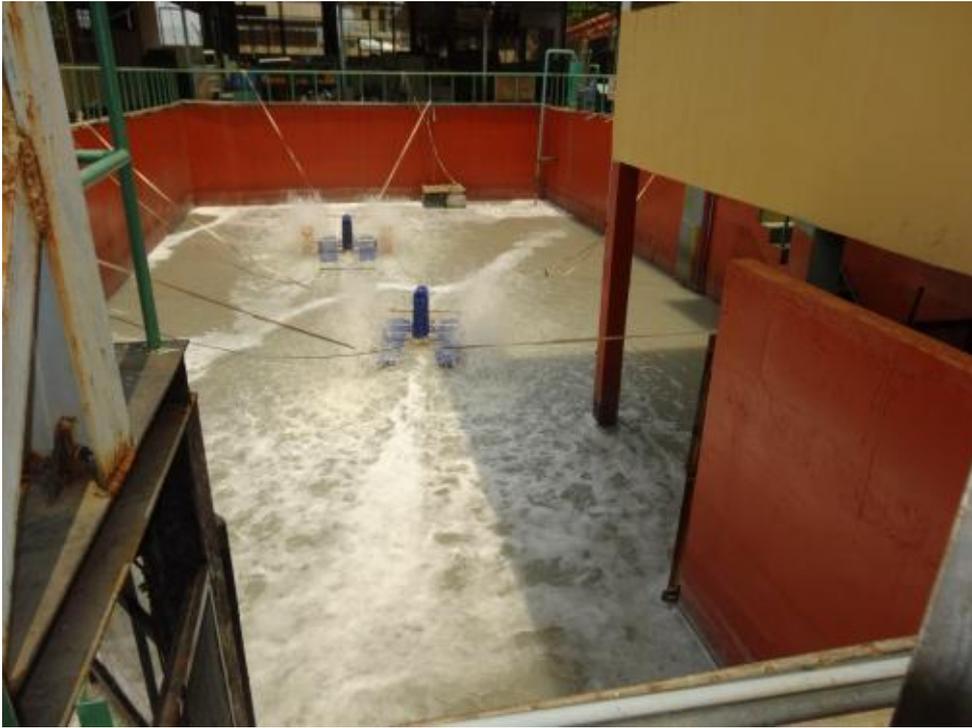
Figure 7.3.4. Water retention pond at the private company site.

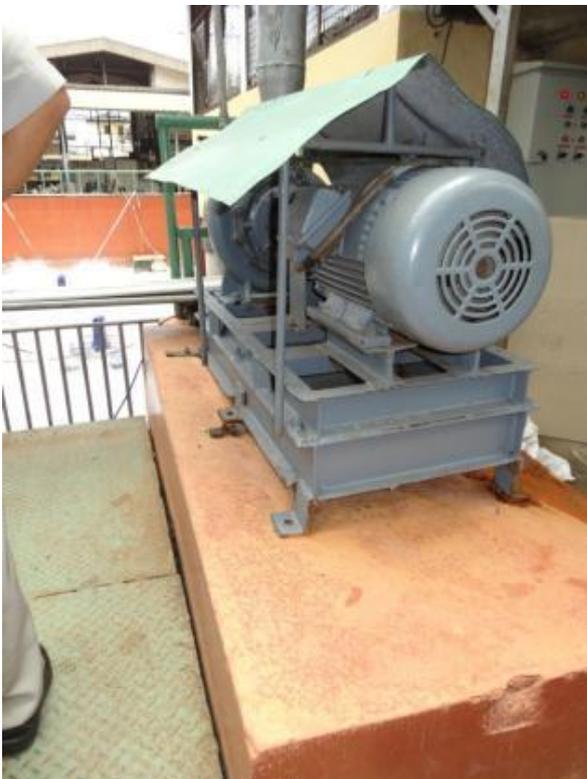
Figure 7.3.5. Elevated fixed drainage pump at private company site.

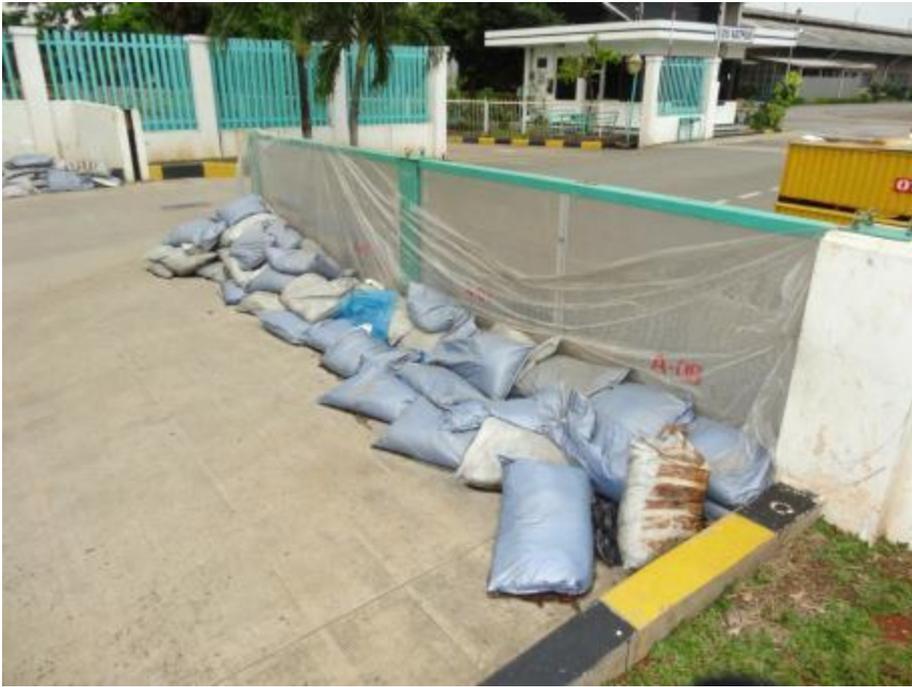
Figure 7.3.6. Sandbags and floodwall.

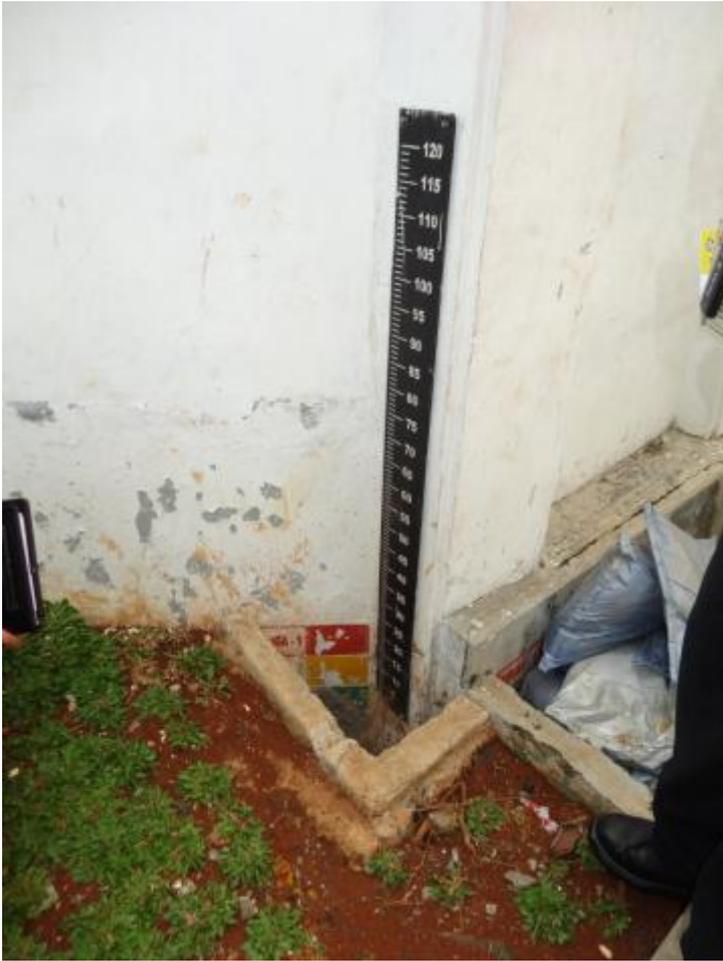
Figure 7.3.7. Water level gauge.
